advice series

A GUIDE TO THE REPAIR OF HISTORIC ROOFS

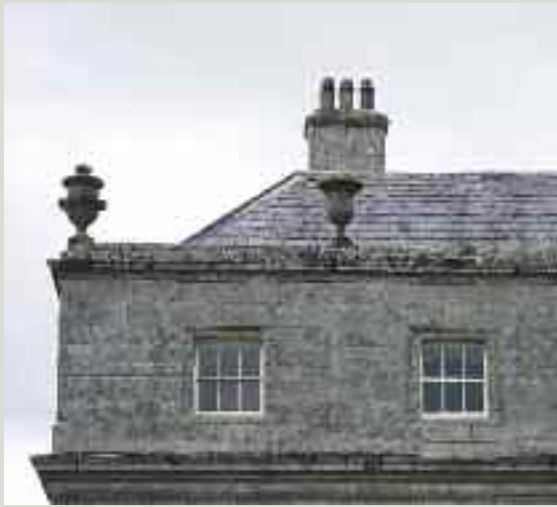
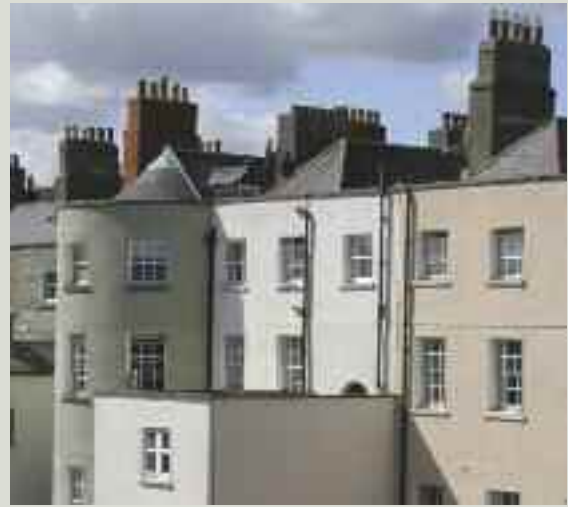
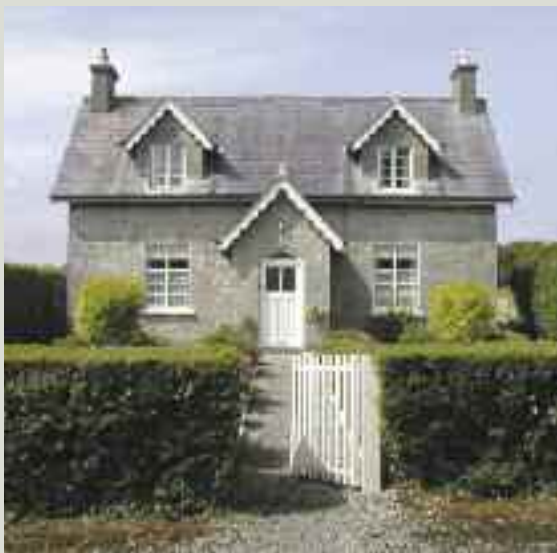
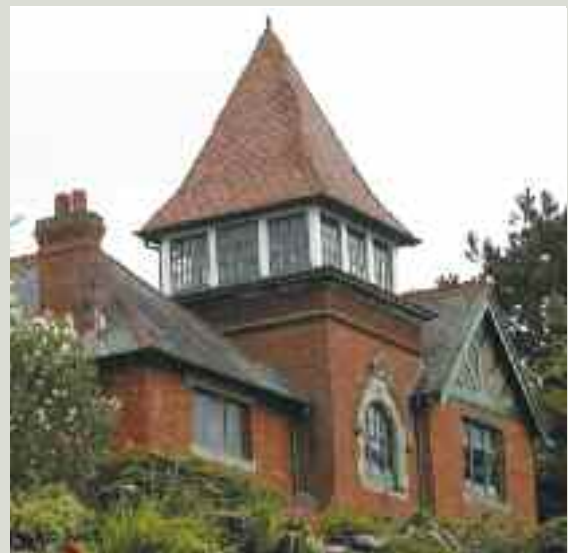
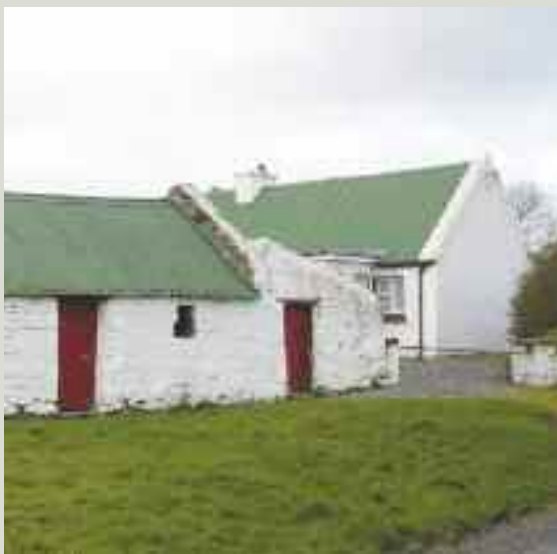
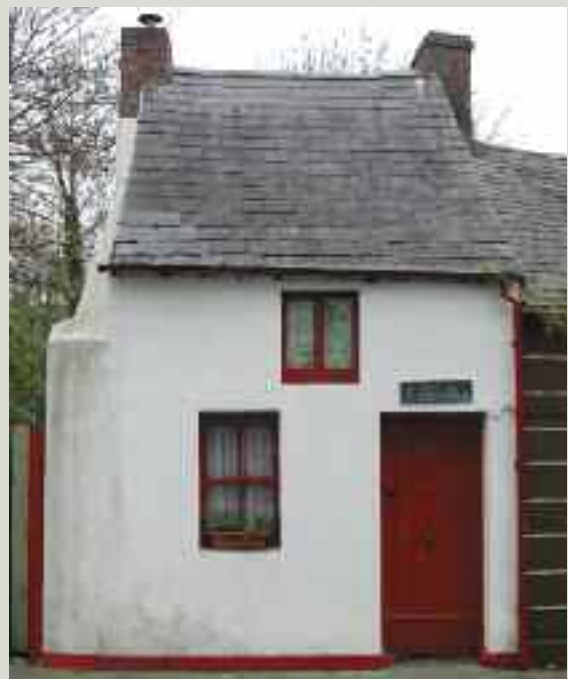
Irish roofs take many forms; the style and choice of materials used were influenced not only by the available materials, but also by architectural fashion

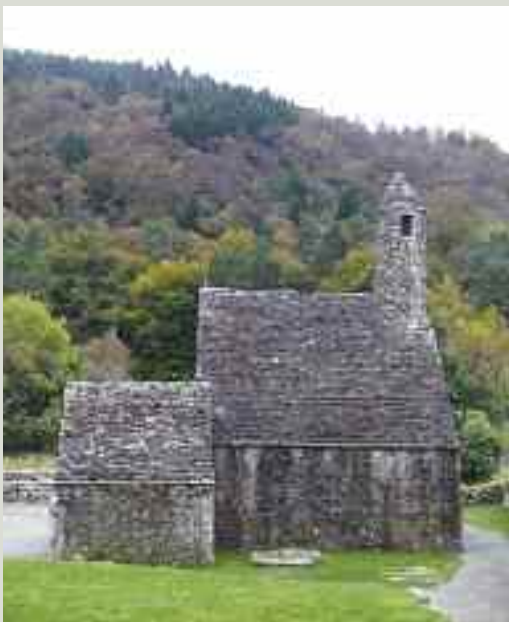
Saint Kevin's Church, Glendalough, County Wicklow. The steeply pitched roof of local stone was built up by corbelling and is supported on walls almost 4 feet (1.2m) thick

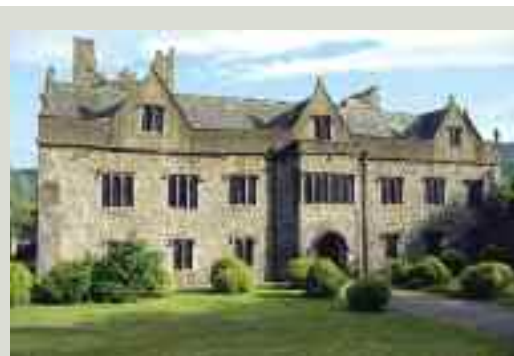
Tower houses were heavily fortified, with their roofs concealed behind battlements. In contrast, the architecture of the sixteenth and seventeenth centuries brought the roofscape increasingly into full view. At Ormond Castle, County Tipperary, the remains of the earlier tower house can be seen rising behind the Elizabethan mansion with its then highly fashionable dormer gables

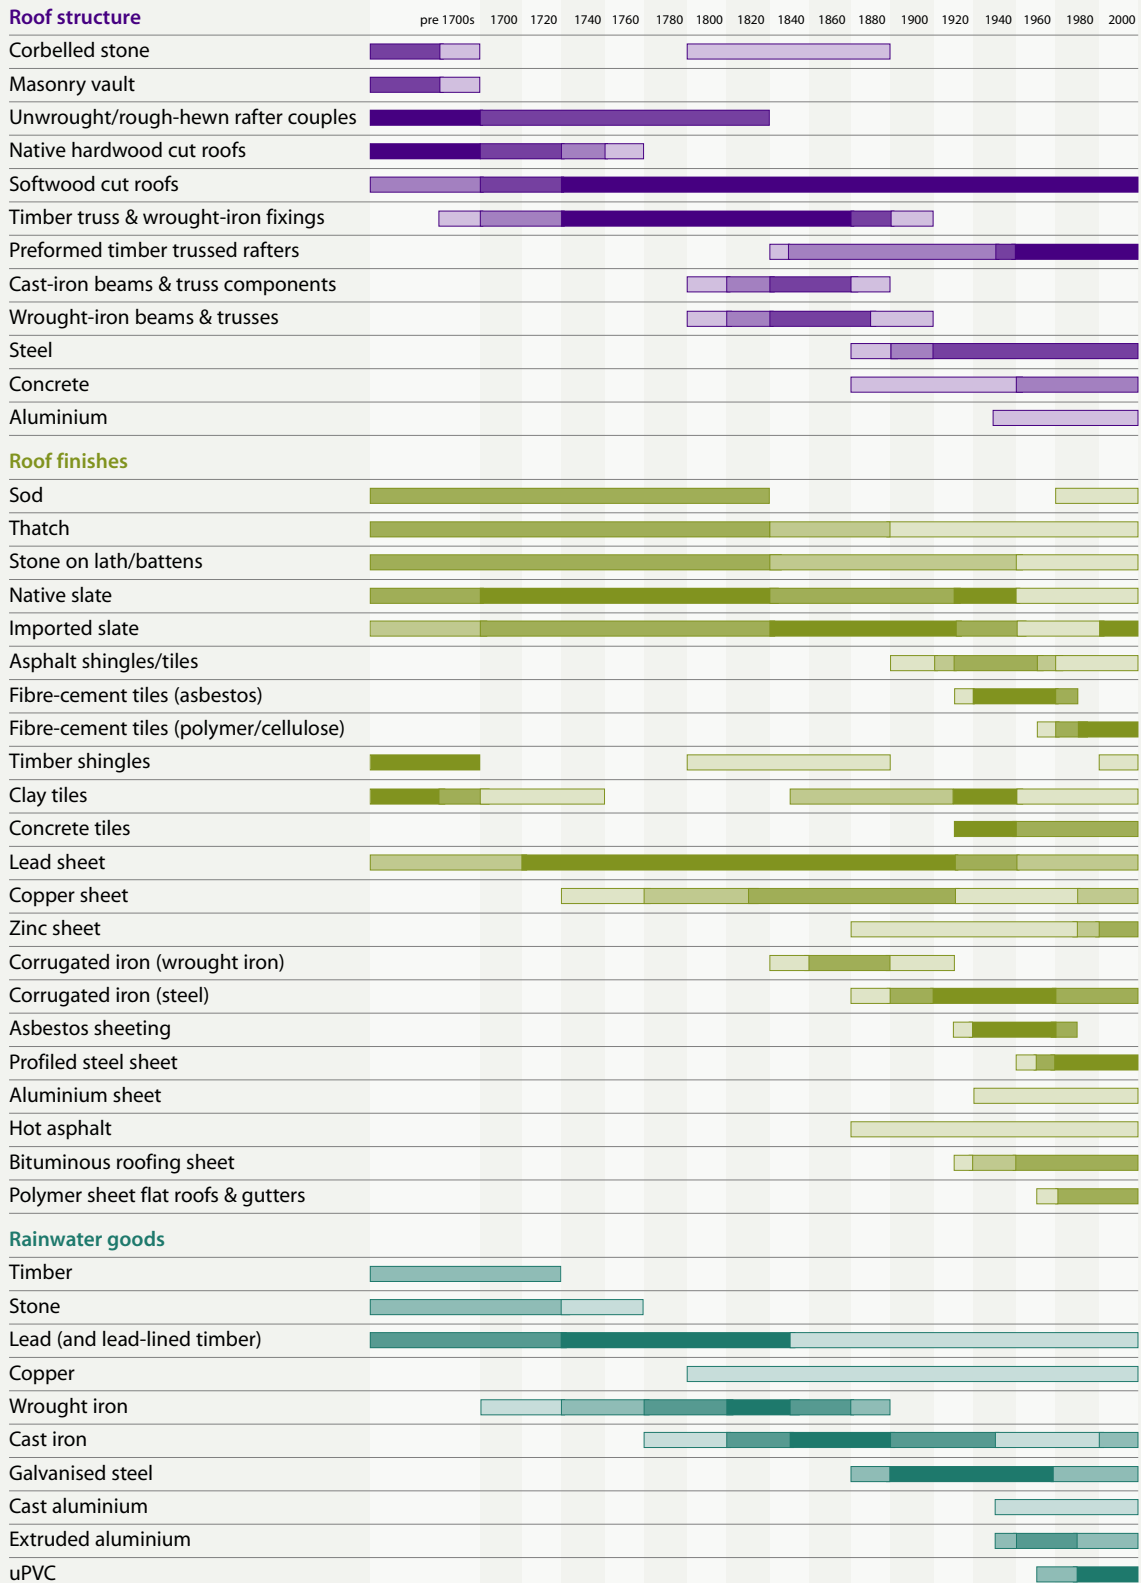
The degree of shading relates to the extent of use of the roofing material: the darkest shading indicates periods when the material was in widespread use while the lightest shading indicates periods when it has been found in use in isolated examples. In the periods where no shading is shown, there is no evidence of use of the material or it was not yet invented.

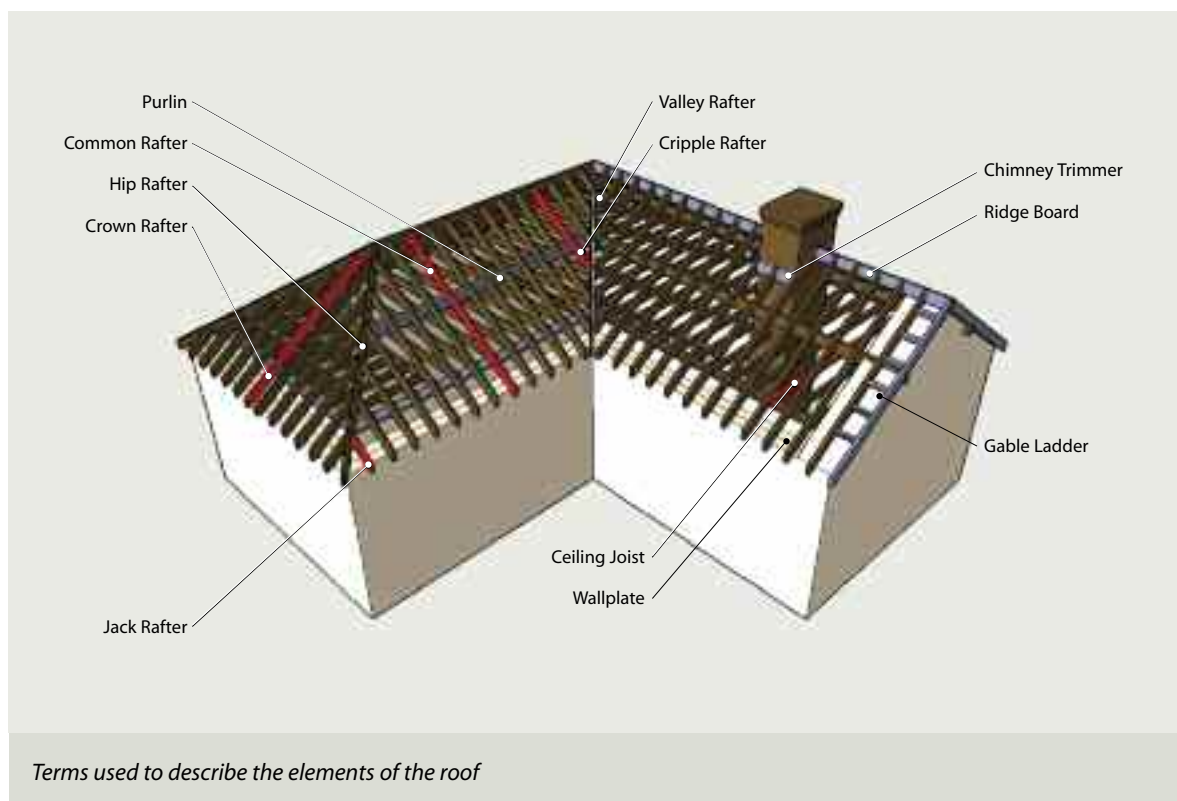
a steep pitch to prevent rainwater soaking into it. In many cases, a thatched roof may still be found beneath the metal covering. Similarly, the position of structural elements such as chimneystacks can provide clues to the date of a structure and to the internal layout of the building. Exposed chimneybreasts projecting from the gable ends of a house may indicate an English influence in the design, while a chimneystack in line with the main entrance of a vernacular dwelling denotes a central hearth protected by a jamb wall.

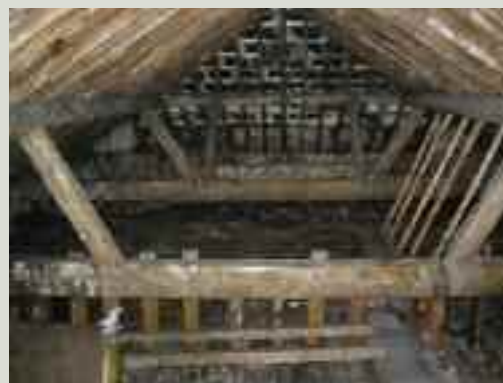
An eighteenth-century re-roofing of a tower house using imported deal

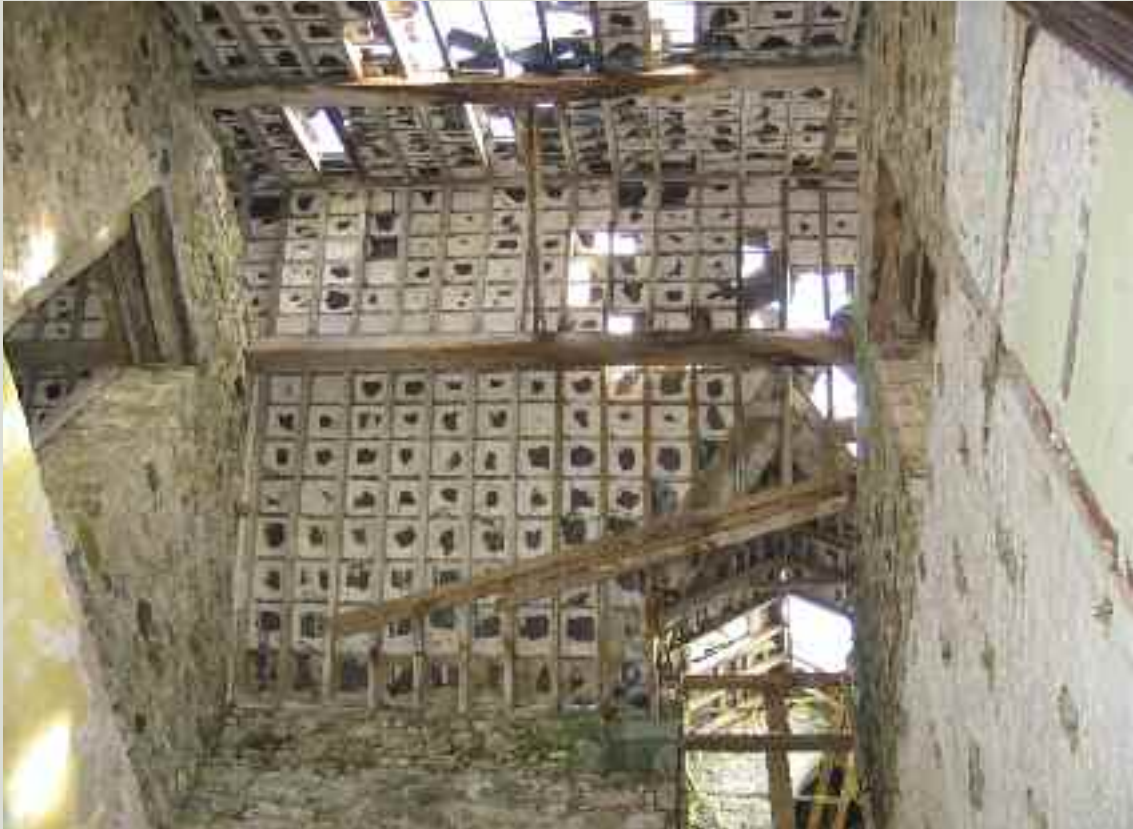
A roof detail particular to Ireland was the practice of continuing the masonry cross walls up into the roof space. Purlins were placed to span between the cross and gable walls to support the common rafters. This proved to be a very economical use of timber and also reduced the amount of skilled carpentry work required

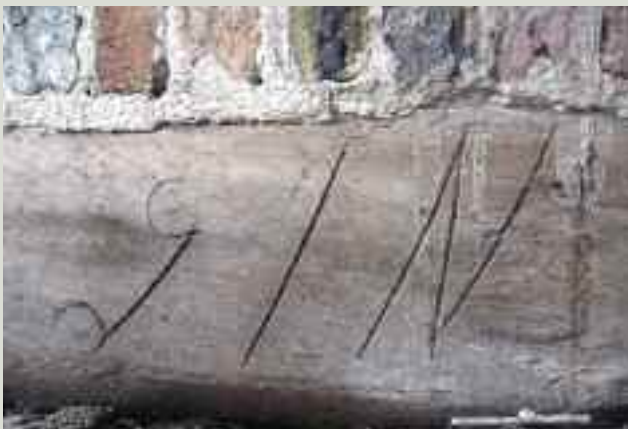
Merchant mark 'g I N' on this bay bressummer was exposed during works to repair this beam and the bay roof. Timber marks, where found, should be recorded and preserved and repair works should avoid concealment

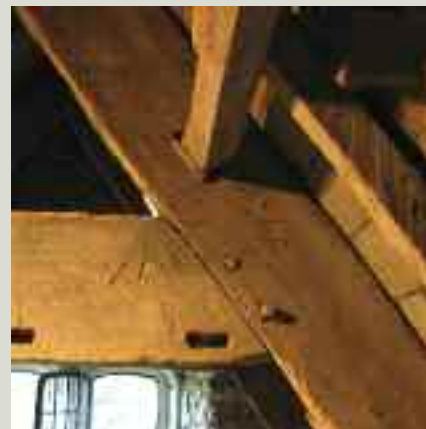
A survey of the timber structural elements of a roof often reveals merchant, religious or assembly marks on the historic timbers. These assembly marks on the oak timbers helped the carpenter to assemble the frame once on the roof. Note the pegged joints and the housing of purlins into frames. This is how roofs were constructed before nails and other metal fixings became readily available

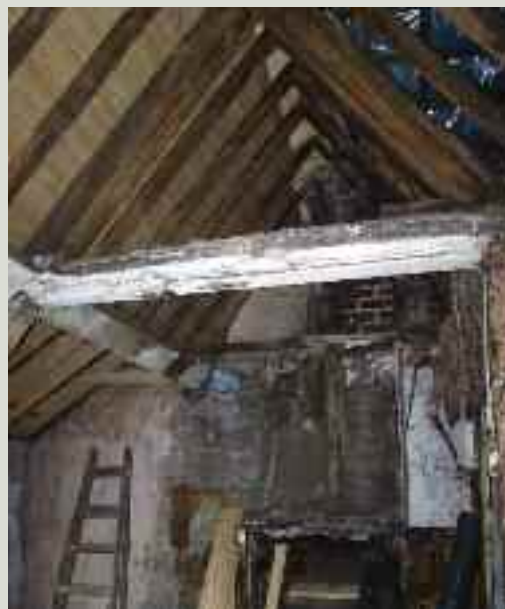
An early-seventeenth century roof showing the original principal roof structure and rafters with replacement sarking boards above (Image courtesy of Tom McGimsey, Mesh Architects)

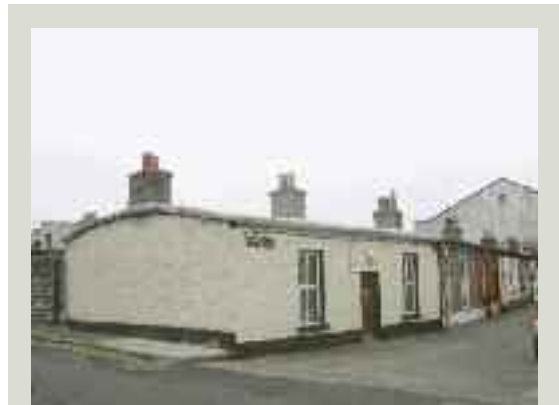
The 'Portlaw' roof was also used further afield for housing schemes, such as here in Harold's Cross, Dublin; also in Clara, County Offaly; Blarney, County Cork; and Carrick-on-Suir, County Tipperary. At one point, these trusses were exported to Germany

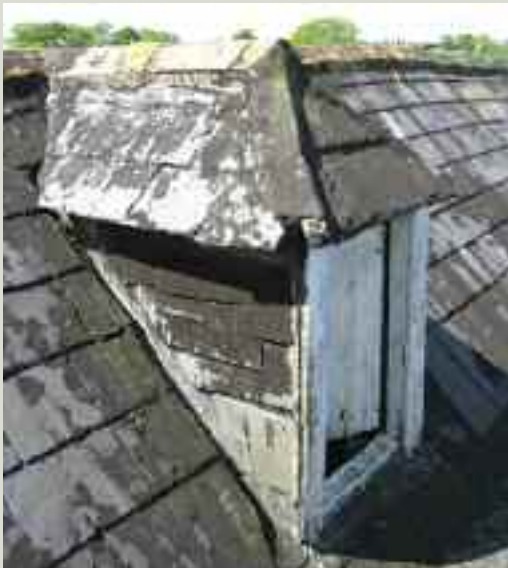
Pitch-roofed hatches, similar to dormers, were used to provide access to the roof for maintenance purposes. They were generally located in the central valleys, constructed of timber and finished with a cladding of slate or lead. By the end of the nineteenth century they had gradually been replaced by hinged cast-iron rooflights, which provided both daylight and roof access

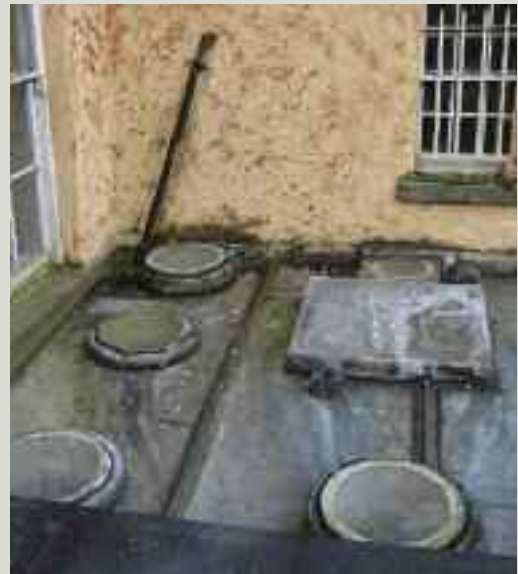
Glazed lanterns of circular and oval form were inserted into roofs as a means of bringing natural daylight into internal spaces such as landings and stairwells. Frequently these lanterns were poorly maintained because of difficulties of access and they were often replaced or covered over with a replacement roof covering. These circular glass rooflights are part of a nineteenth-century alteration

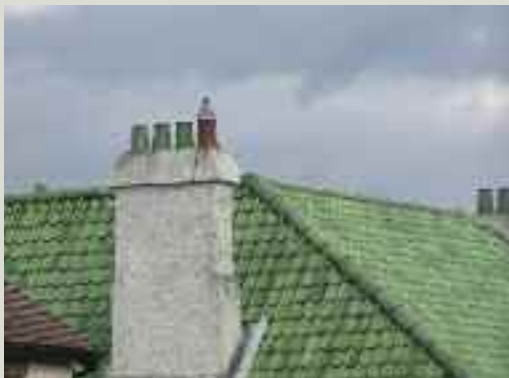
Glazed terracotta chimney pots are unusual, but examples with green, black and dark brown glazes can still be found with a simple roll-top detail. In this example, the bright green glazed pots match the glazed roof tiles. Further variations included tall dark brown terracotta pots with serrated tops and short plain black pots like crowns

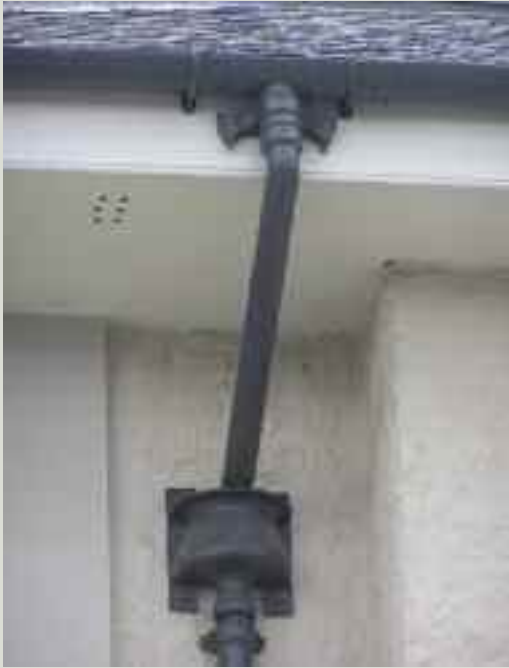
Cast-iron rainwater systems often copied the design of leadwork, but the stronger nature of cast iron enabled the use of shallow collars and two-point fixings rather than the deep collars needed to support lead rainwater goods

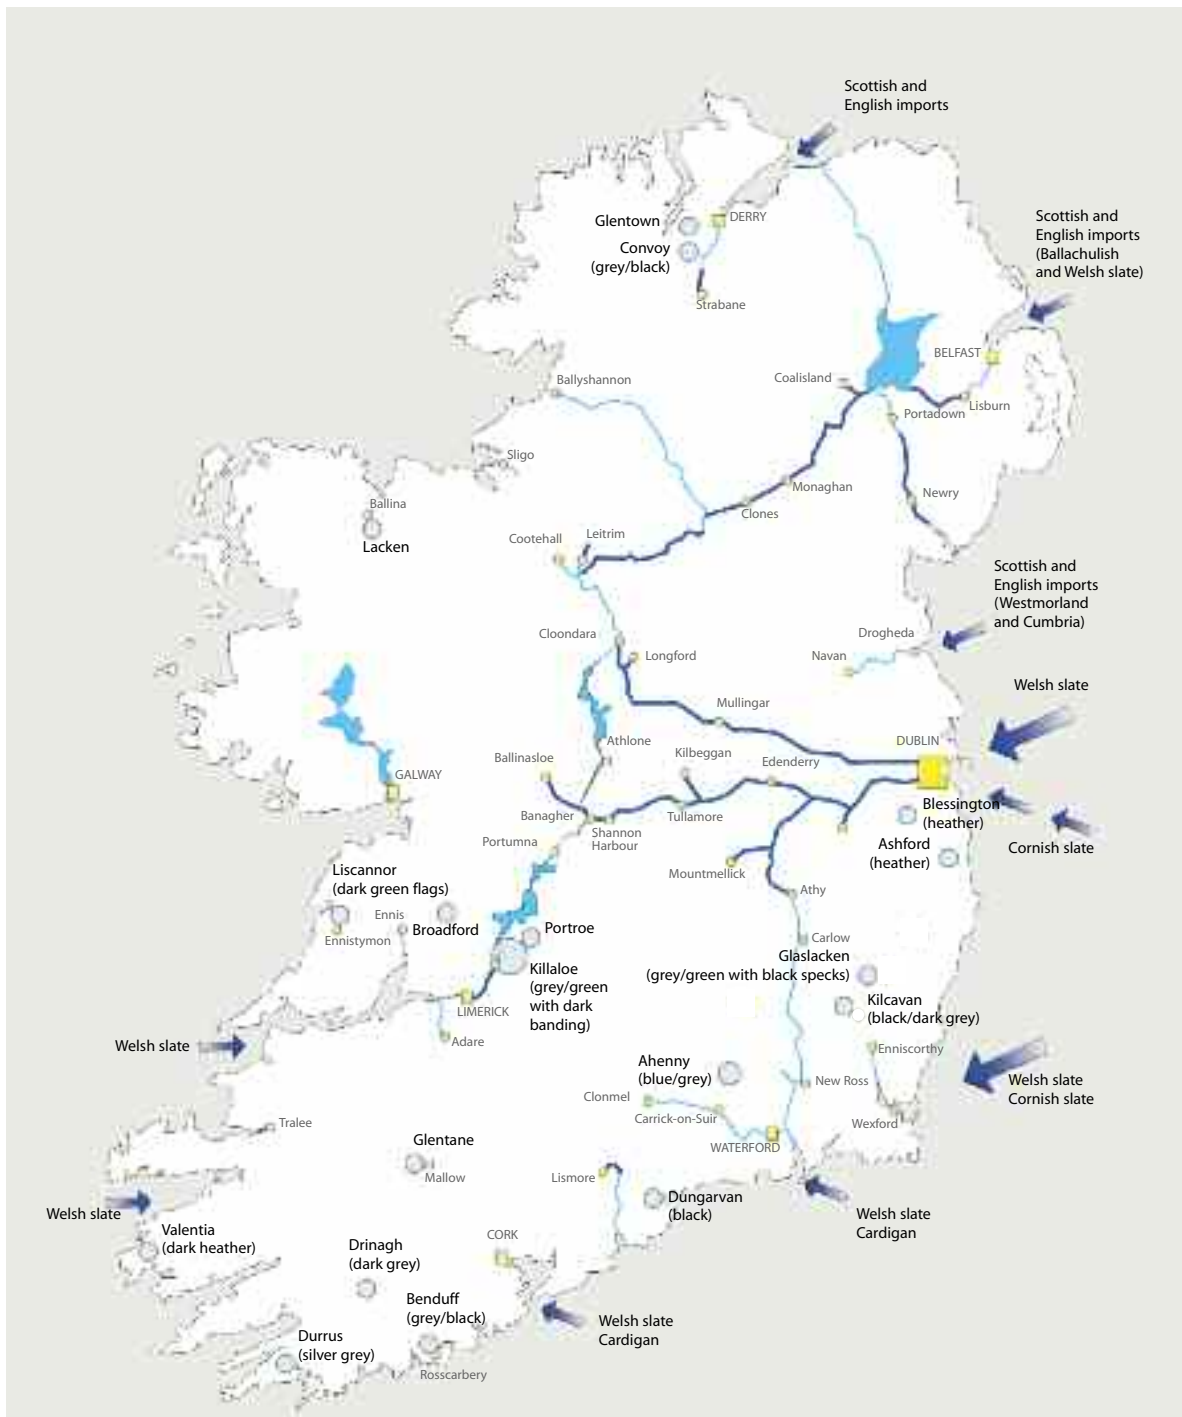
Slate quarries and locations of slate supply: this is not an exhaustive mapping, as research suggests that many sites worked on demand to supply local needs

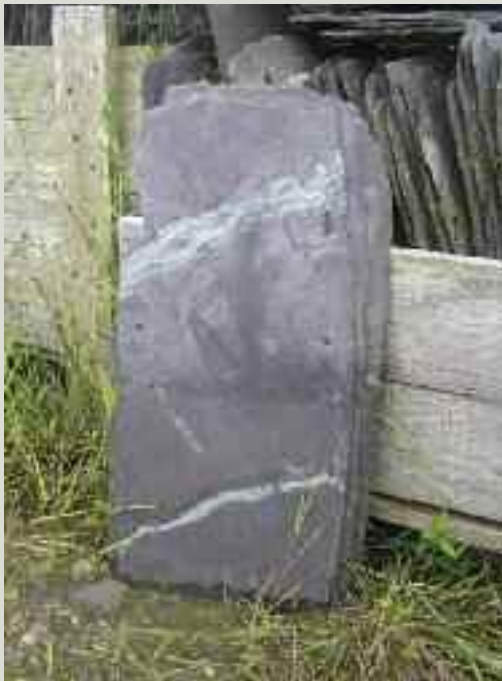
Salvaged sample of Ahenny slate. A series of quarries on the Tipperary/Kilkenny border made this one of the more prolific areas of slate production in Ireland in the nineteenth century

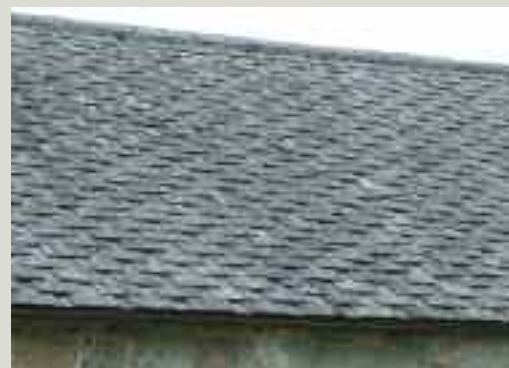
A method of slating sometimes referred to as 'open slating', 'hit-and-miss slating' or 'Scottish cant'. This slating pattern economised on the number of slates used and was primarily used for outbuildings. It is difficult to repair without face-fixing and the amount of exposure of slate surface can make the slates brittle for reuse

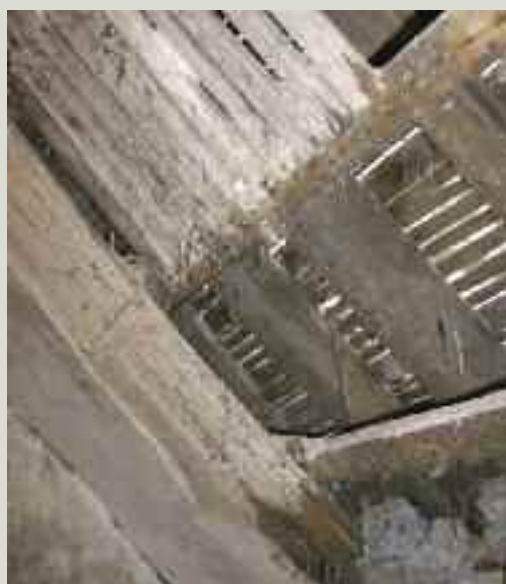
The recent discovery, within a later roof space of part of the former medieval friary in Ennis, of closely spaced riven laths fixed onto covered-over rafters substantiated the presence of an earlier structure within the historic fabric

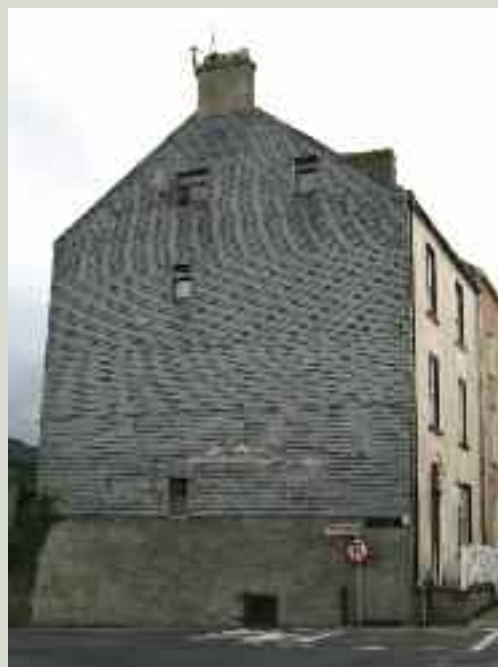
The best surviving examples of native Irish slate are most often found in vertical slate hanging, as it requires less frequent replacement than roofing slate. It is thought that this example of a slated gable is covered in Ahenny slate from the nearby Ormond quarries in the Carrick-on-Suir area

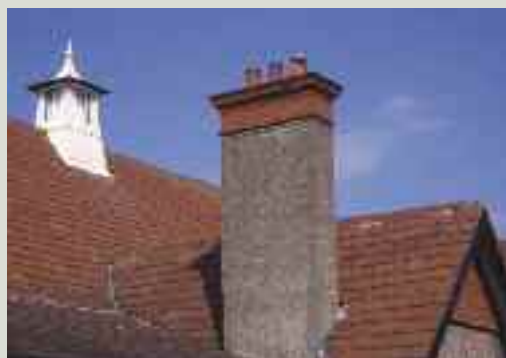
An Arts and Crafts style clay-tiled roof with tile hanging to the upper part of the gable

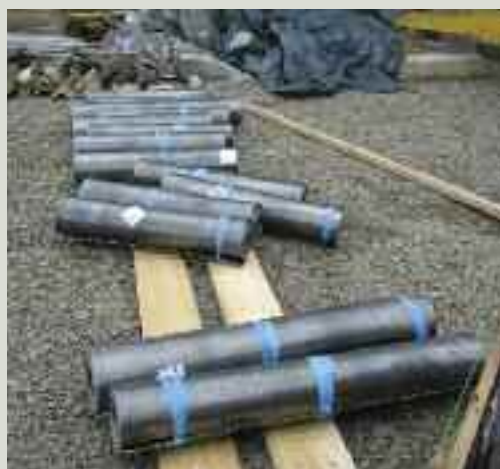
New lead sheet is supplied in rolls. Depending on the code specified, it can be exceedingly heavy and needs to be lifted with care. Despite this it is vulnerable to theft

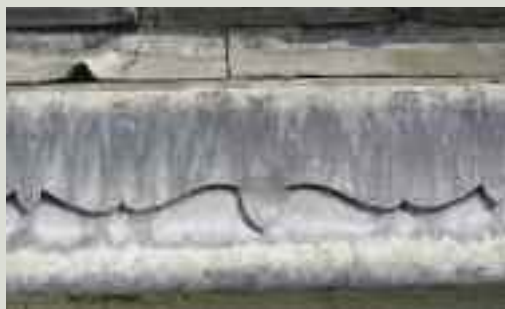
In high-quality work, the visible edges of lead flashings were cut to decorative shapes

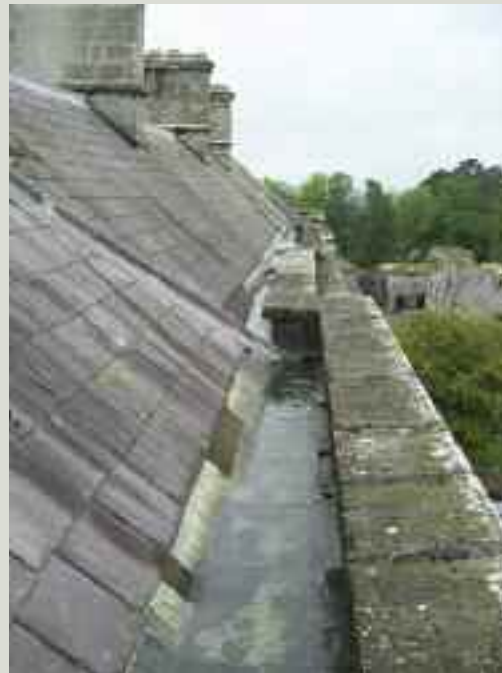
Copper can be laid to very shallow falls as in this copper-lined parapet gutter. It can be used to resolve situations where the falls necessary for stepped lead gutters cannot be achieved

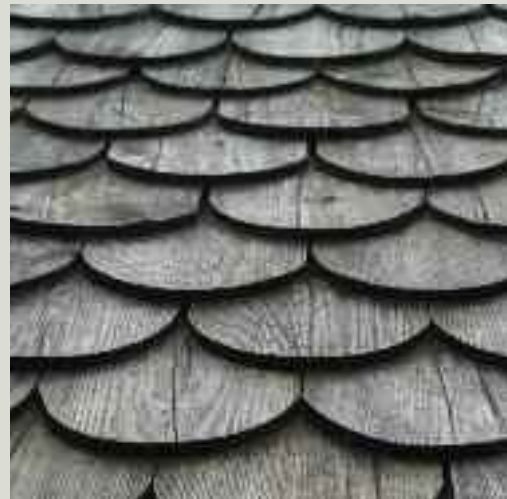
Now usually machine-sawn cedar, chestnut or oak, shingles were traditionally cleft or split. They can be found on the roofs of buildings such as a cottage orné or on decorative architectural features such as roof lanterns or lych gates

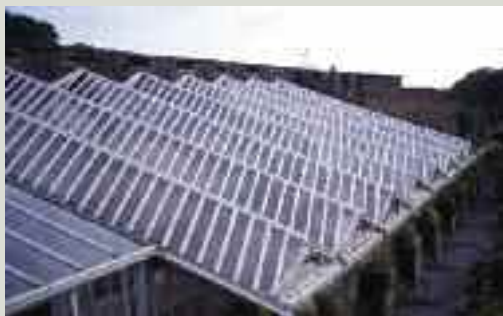
Glass roofs, using timber or iron structural elements, were used on conservatories and greenhouses and can be extensive

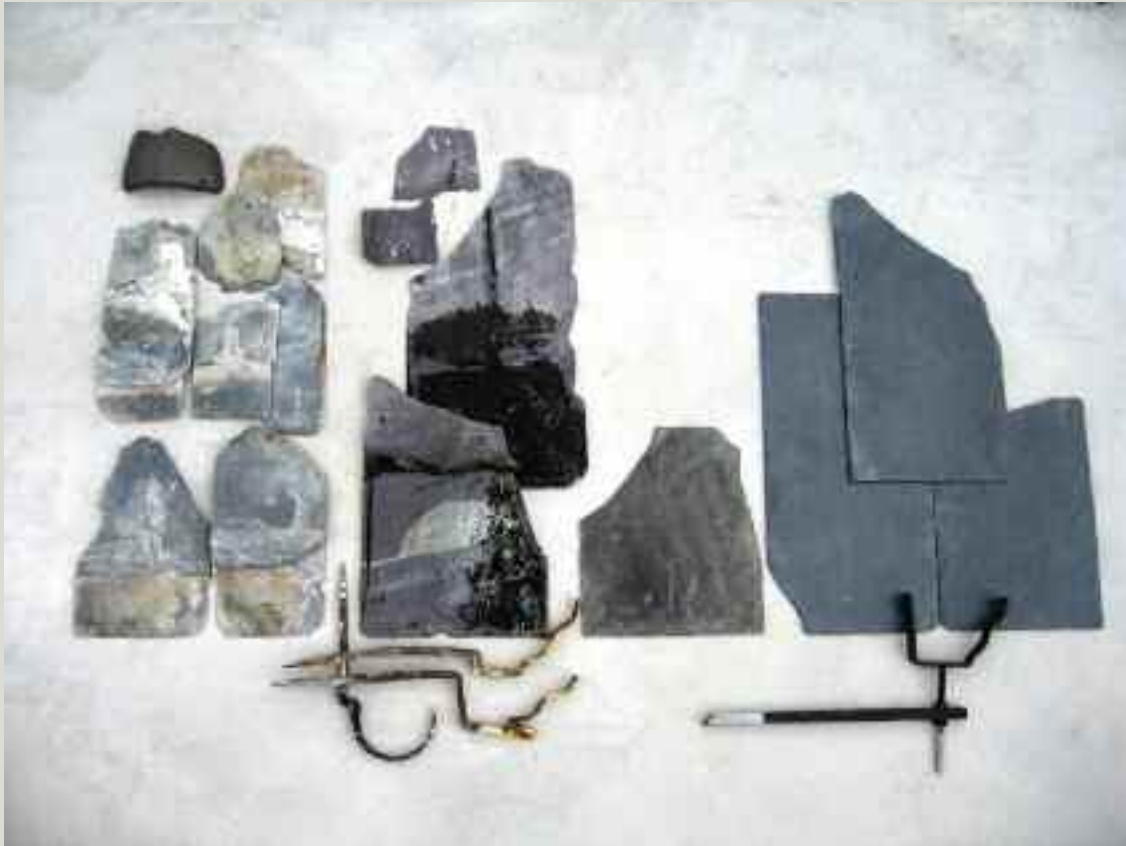
This set of slates indicates a sequence of re-roofing projects, over a period of centuries, on an early eighteenth-century country house. On the left, the small greenish, hand-dressed slates, held in place by pegs fixed into lime mortar, are thought to represent the original roof covering. Clay tiles may have been used to cover the ridge; the fragment shown here (top left) was found in the attic space of the house. An extension to the house in the 1800s appears to have been the impetus for re-cladding the entire roof with a blue-grey slate in a gauged slate pattern, possibly Ahenny slate (second from left). This roof survived until the mid-1960s, when neglect over time had caused serious damage and undermined the roof covering. The roof

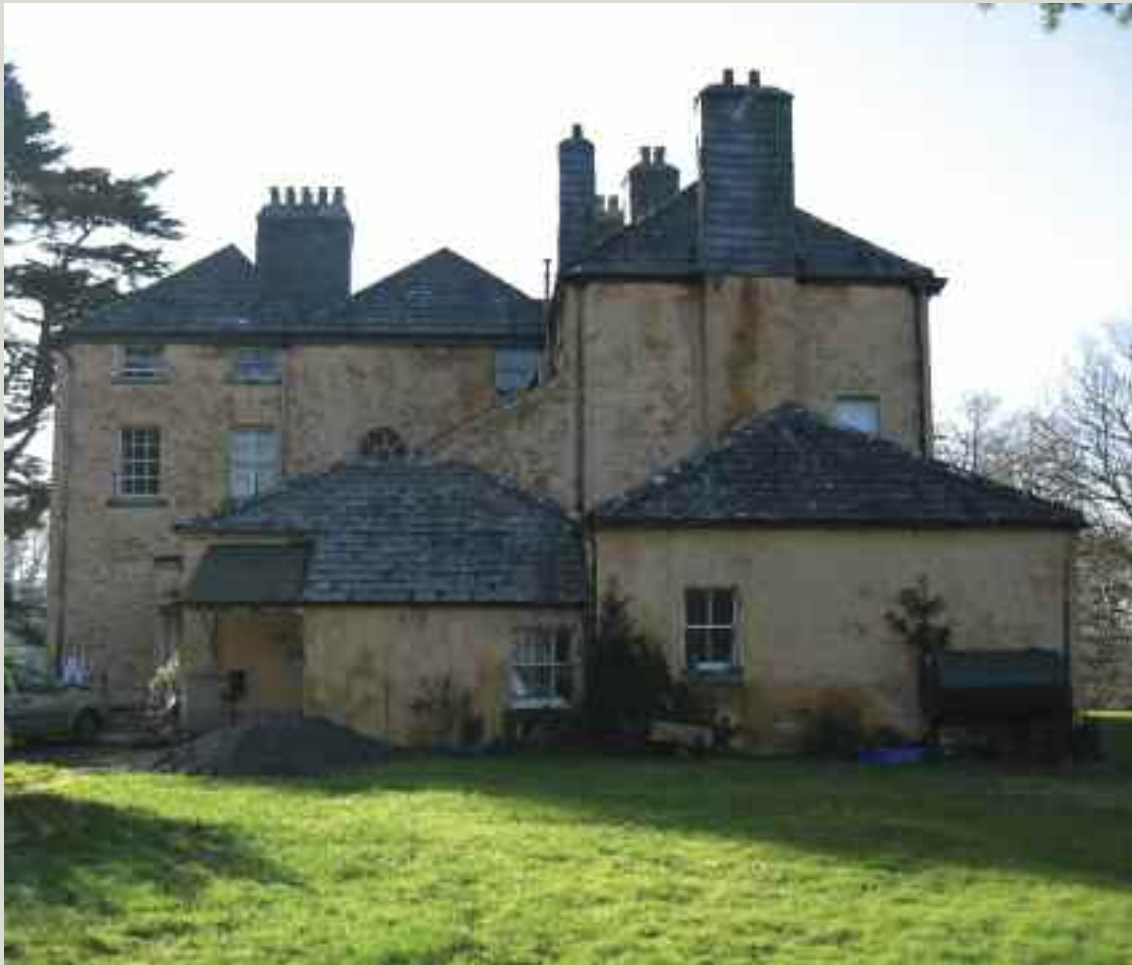
This house has a particularly interesting roofscape, complex in form with several valley gutters and a series of slate-clad chimneystacks with plain clay pots. This type of roof is known as a gauged slate roof because of the use of courses of diminishing slate sizes from eaves to ridge, probably of imported Welsh slate. The ridges are covered in stone, bedded in lime mortar with tight joints. The character and appearance of the roof were

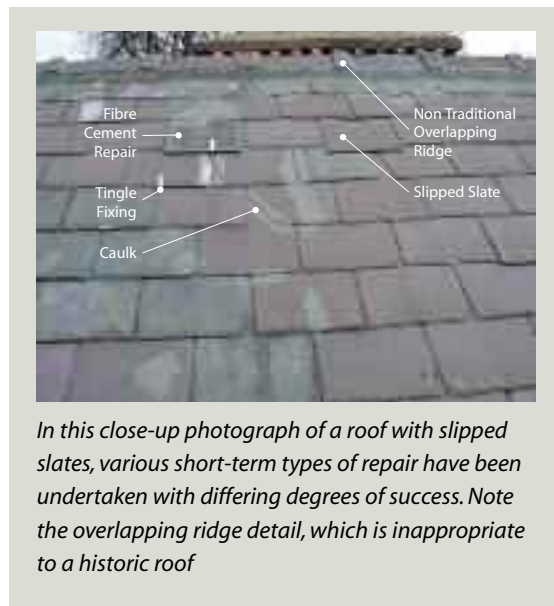
In this close-up photograph of a roof with slipped slates, various short-term types of repair have been undertaken with differing degrees of success. Note the overlapping ridge detail, which is inappropriate to a historic roof

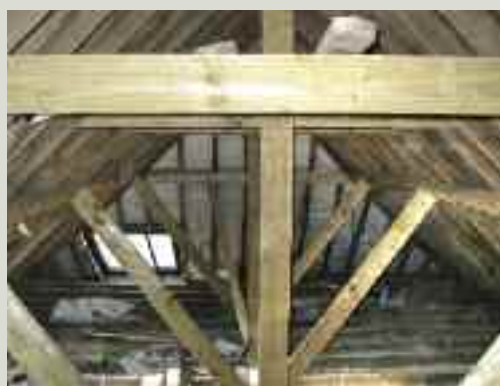
These rafters were originally undersized for their span and had deflected, causing slates to lift or slip, and thus allowing water to enter the roof space. To correct the problem, this additional support structure was added during roof repair works

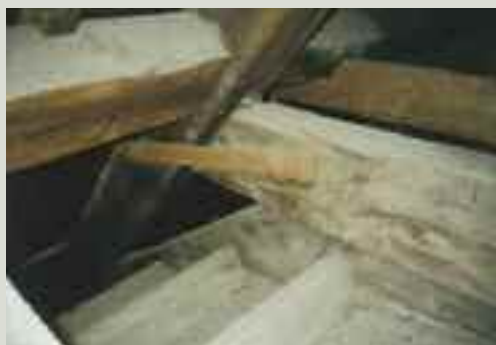
The extent of movement in this roof truss is serious, indicating not only the poor quality of the original detailing but also potentially serious movement in the main supporting walls below

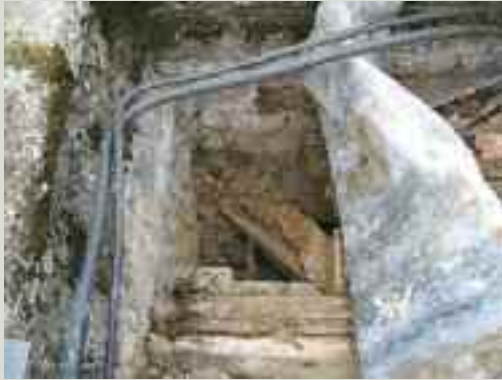
Rot beneath this section of parapet gutter resulted in localised ponding of rainwater, exacerbating the problem and leading to wet rot damage to the truss end. Note that bonding timbers embedded further down the wall may also be affected by such leaks

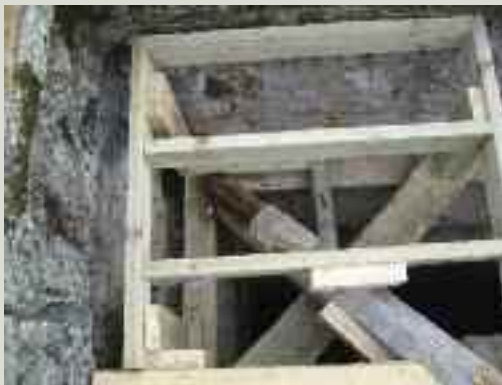
Additional support was added on the diagonal below the truss end, thus avoiding the need for new timber splice and steel connections or the local removal of the rotten timber truss end. The timber that had supported the gutter above had to be fully replaced

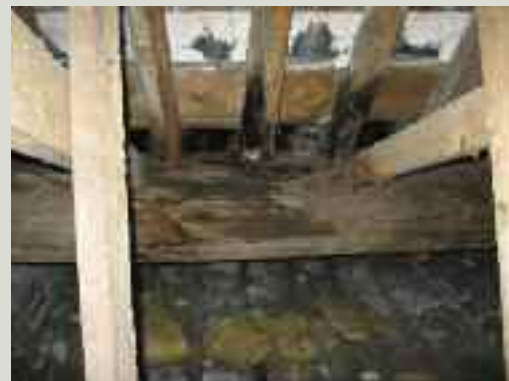
Evidence of wet rot damage to a roof beam and rafters under a tapered valley gutter. Only about ten per cent of the beam section was degraded, so no strengthening works were required to the beam. The rotted rafter ends, however, needed replacement

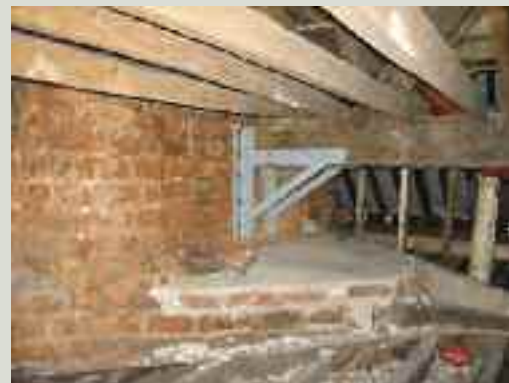
A new steel support bracket has been supplied to support this roof beam severely affected by wet rot at a chimney breast. The chimney flashings above, which had failed, were also repaired as part of these works

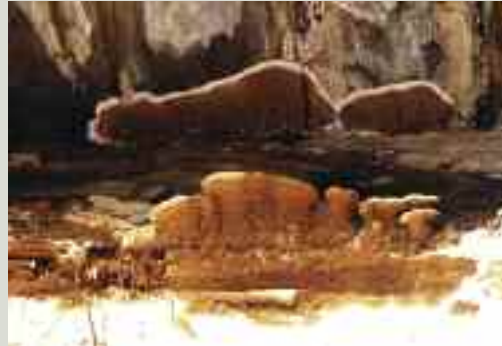
The fruiting bodies of the serpula lacrymans fungus can be identified by their rust or orange colour, usually with a white edging

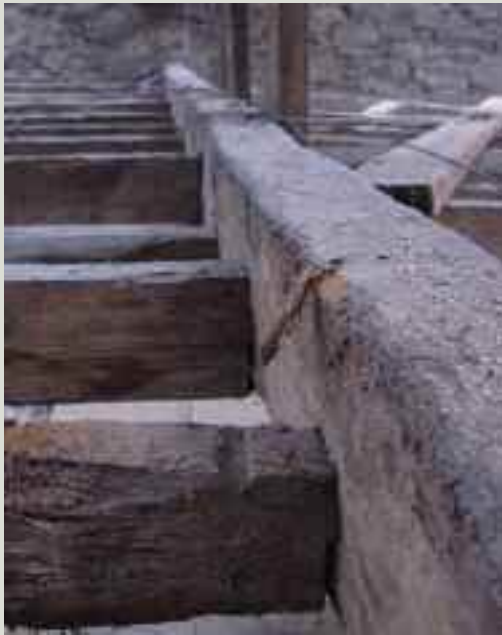
Furniture beetle has damaged only some of the faces of these timbers – these are the sapwood faces of ceiling joists. The slight shrinkage of the joists where they are mortised into the ceiling beam was not seen as problematic in this case but, if the displacement were any greater, it would need thorough investigation

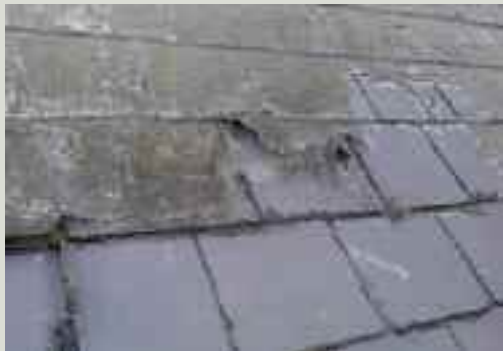
The process of covering a leaking slate roof with a bitumen covering was known as 'turnerising.' It is ineffectual and damaging and should never be carried out on a historic roof. Furthermore, it prevents the slates ever being salvaged for reuse

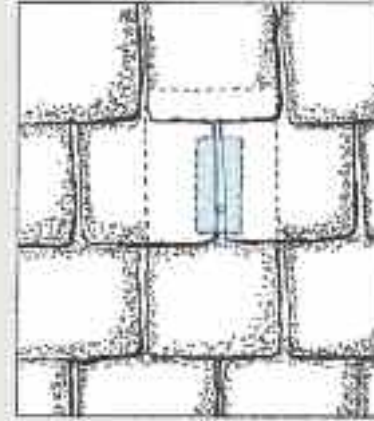
The 'bib' repair, which is used to re-affix a slipped slate

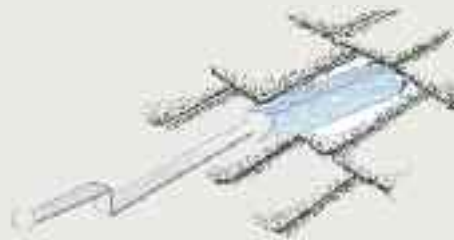
Here, a partially folded metal piece is slid under the upper slate as part of the bib repair. The metal is partially folded to allow the metal to sit above the nail head. The metal used should preferably be a painted aluminium or copper but should be matt in texture

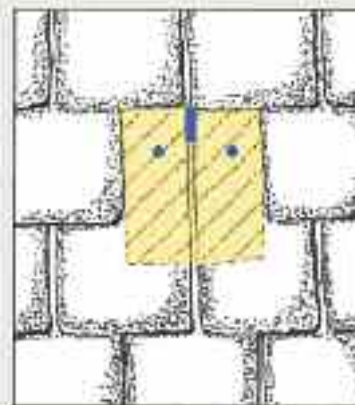
The slipped slate (in yellow) and the areas most likely as a result to spring a leak (in blue): the nail holes and the top of the joint

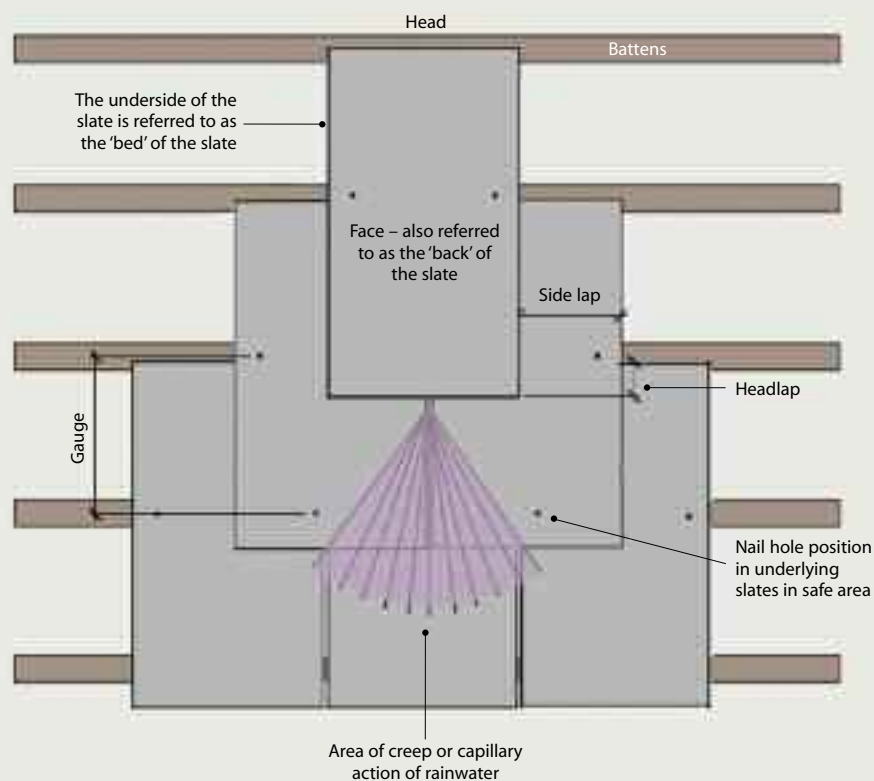
This drawing shows the terms relating to a slate and its fixings and illustrates the main area of water run-off on a double-fixed slate. If this area is cracked or holed or not adequately lapped, this will most likely be the area in which a leak will occur. If a leak occurs in the area called the headlap by way of a crack, it can be very difficult to spot, as the overlying slate conceals it from above and the

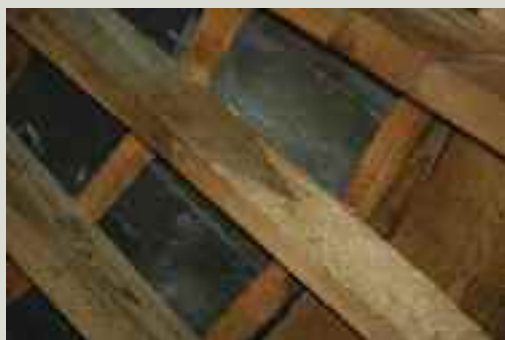
The use of a traditional scarf joint repair to damaged rafter ends is particularly worthwhile where the roof structure is exposed to view (Image courtesy of the Irish Georgian Society)

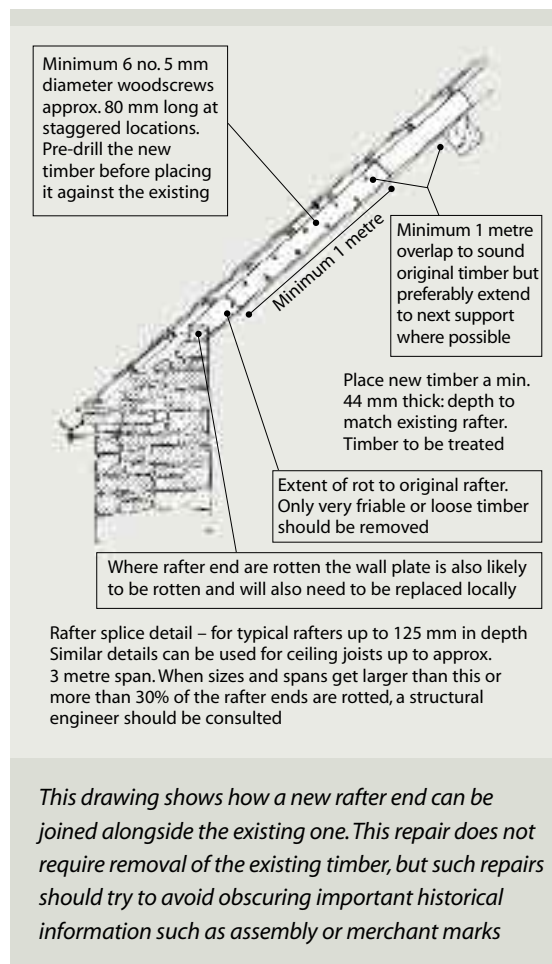
CHOOSING THE RIGHT TIMBER FOR REPAIRS

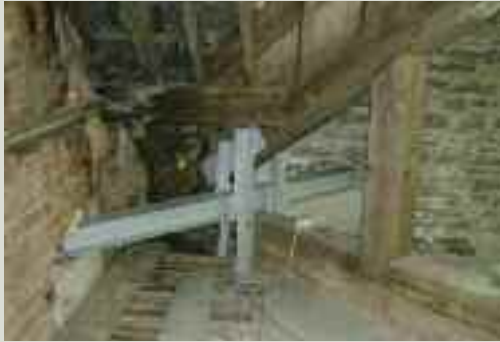
Added support has been given to the main hip roof truss at an internal valley. This repair detail used prefabricated steel elements and tooth plate connectors, but avoided the need to open up the recently repaired valley finishes and does not obscure the original truss details

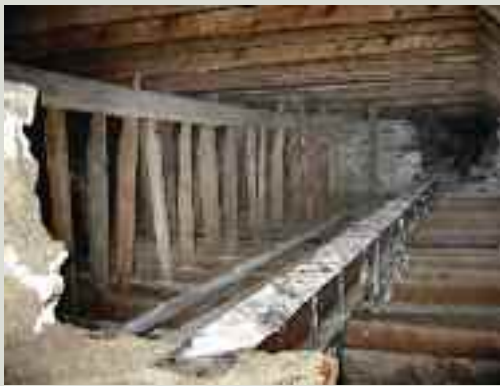
Two consecutive corrective structures to provide additional support to undersized ceiling joists. The first intervention (upper left) occurred early in the roof's history and consisted of the addition of a timber beam and timber hangers to give extra support to the ceiling joists. The new beam itself then deflected. Further corrective measures were taken using a new steel beam (lower right). Note that all original timbers were retained intact and the history of the roof and successive repairs can easily be read

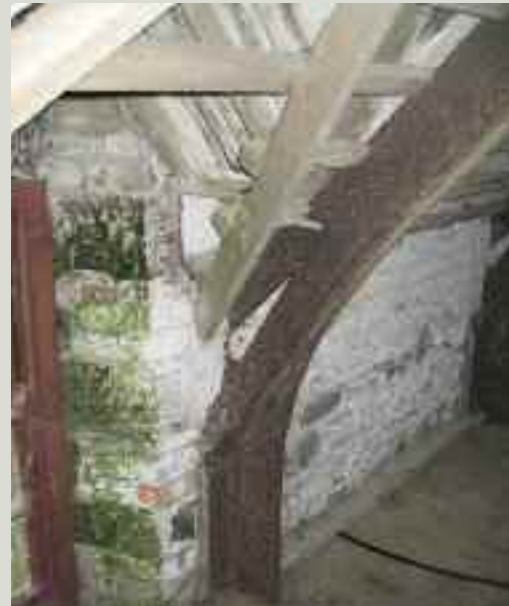
Ferrous metal roof structures should be regularly checked for corrosion, particularly at supports and where built into potentially damp masonry. Where there is significant corrosion of the ironwork, the masonry is likely to crack, as the products of iron corrosion (rust) are approximately eight times the volume of the iron itself

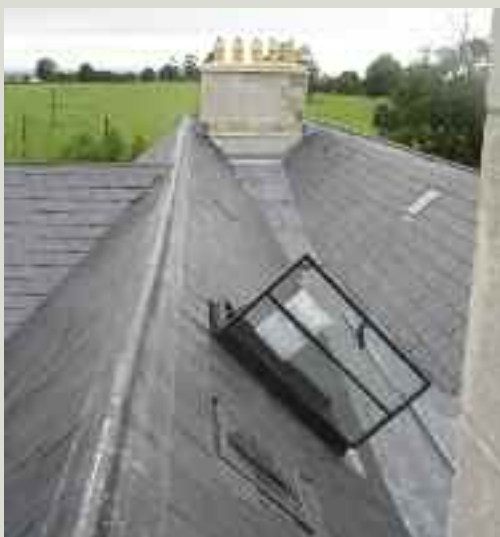
There are several contemporary products available, of which the side-opening rather than top-hung skylight type is possibly the most convenient for providing access for maintenance inspections of the roof
