advice series

A GUIDE TO THE REPAIR OF HISTORIC ROOFS

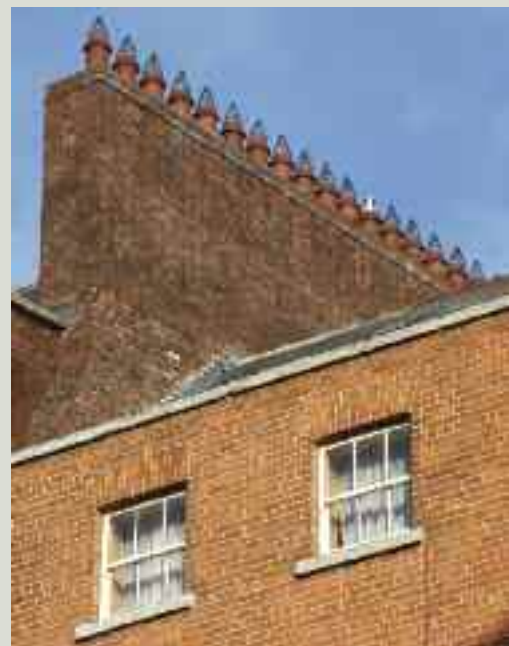
Chimneystacks are prominent features and add considerable character to a historic building. They are integral to the design as well as to the original use of the structure and, even when redundant as vents for fires, play an important role in providing ventilation to the interior of a building

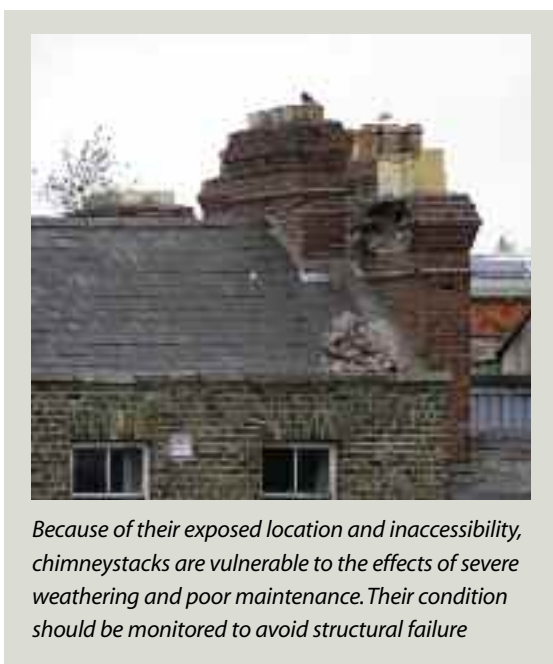
Because of their exposed location and inaccessibility, chimneystacks are vulnerable to the effects of severe weathering and poor maintenance. Their condition should be monitored to avoid structural failure

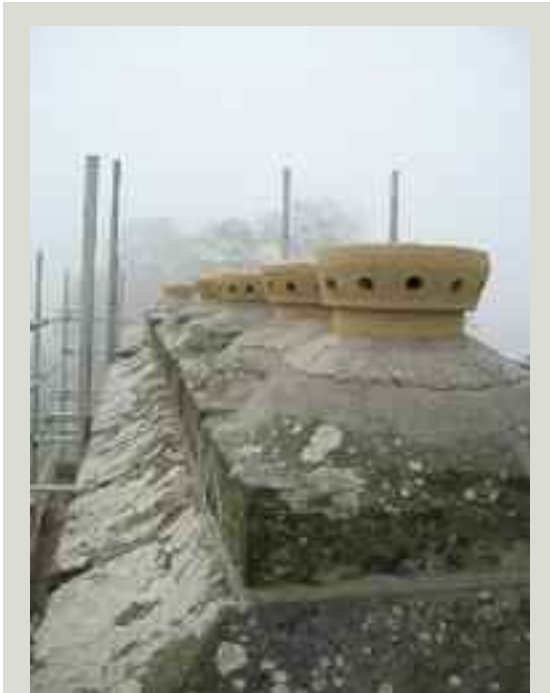
From about 1900 onwards, the insertion of chimney trays into brick stacks became standard building practice. A chimney tray is a lead tray inserted at roof level into a chimneystack, forming a barrier to moisture ingress. In combination with a DPC below the coping and with flashings at the base of the stack, water is prevented from passing through the brickwork and entering the attic space.

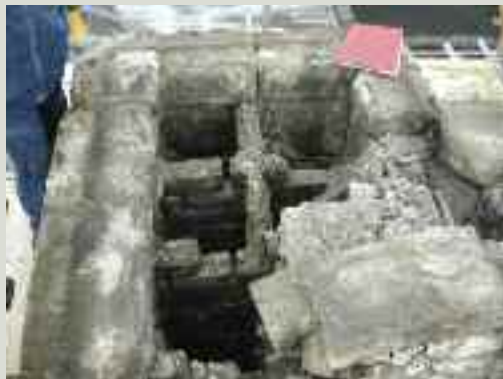
Many older flues have little more than half-brick fin walls called 'feathers' within the stack separating the flues from each other. These can be poorly tied in or even entirely missing as the result of chemical attack from soot, heat damage or over-vigorous cleaning with soot brushes

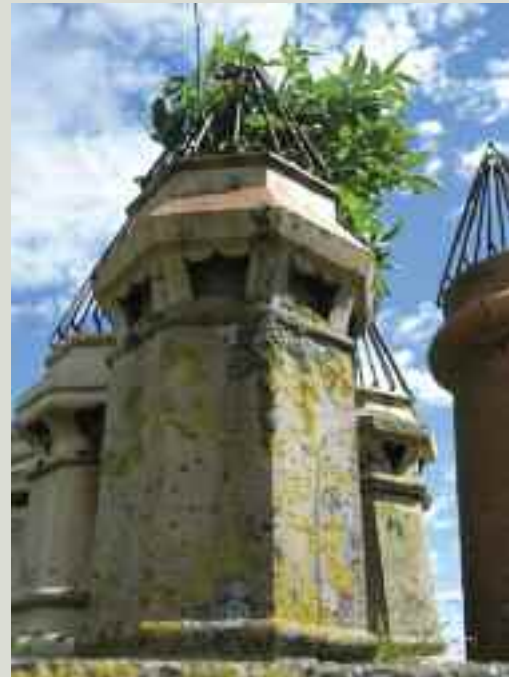
The use of wire crow guards prevents birds from nesting in chimney pots, but does not stop plants rooting in blocked flues

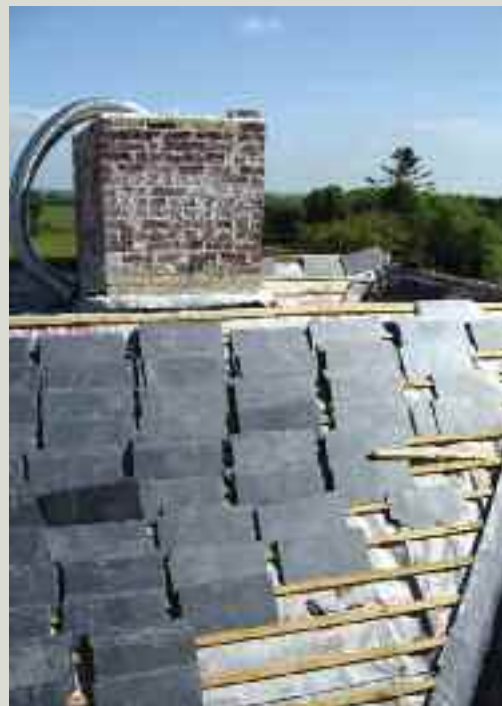
Flexible stainless steel flue being inserted into a historic masonry flue

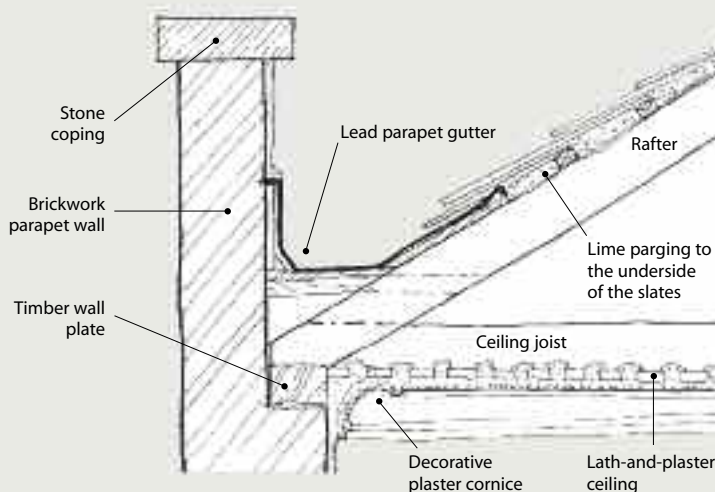
The use of lead flashings to parapets in excessive lengths that deteriorated, cracked and split under pressure from thermal expansion has resulted in water soaking into parapet walls and main walls below, often causing deterioration of the bearing ends of roof trusses, beams and joists.

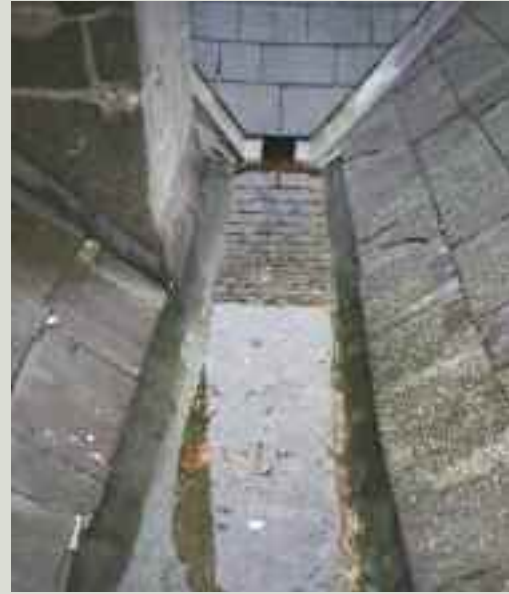
View of a defective valley gutter with a shallow fall that is now holding water. Birds' nests in the outfall of the secret gutter (seen at the top of the image) blocked this roof outlet

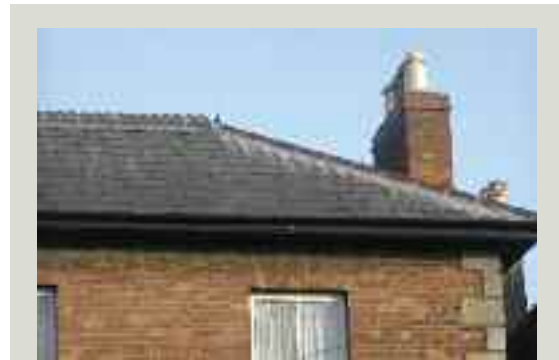
Incorrect bedding and detailing, with fat joints to the ridge and hip tiles, are visually very disruptive and inappropriate to a historic building

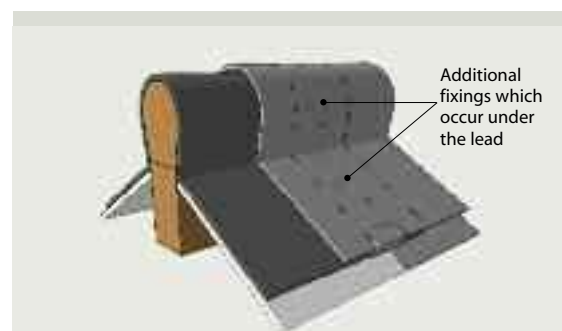
The Lead Sheet Association advises a modification to the profile of the 'broom handle' timber roll and promotes instead the use of a more elongated section in treated softwood to reduce the likelihood of the pinched lead cracking along the roll

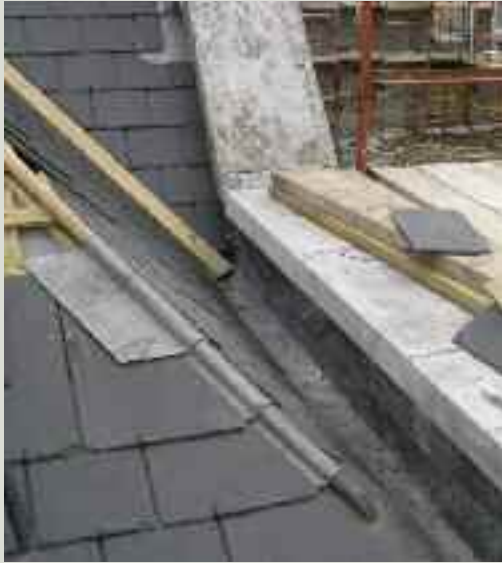
Interleaved soakers: a variation of the external lead roll is the cloaked version seen on hips of roofs, which conceals much of the leadwork below the slate courses. In this detail, the lead flaps are interleaved with the slate on the ridge or hip. If this detail requires repair or replacement, local re-slating of the roof will be necessary to access and replace the damaged leadwork

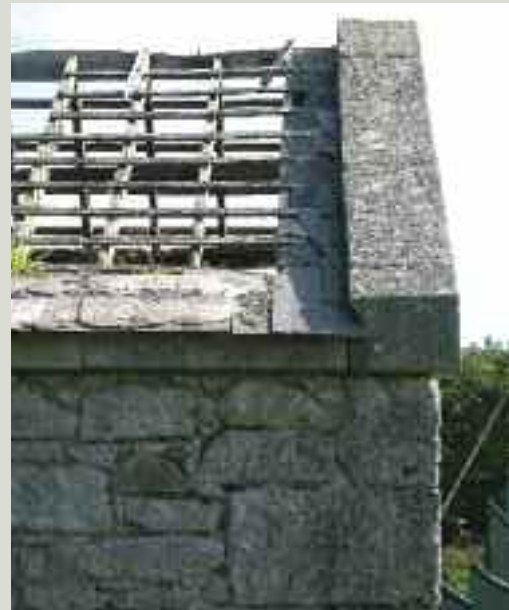
A gable detail where the verge is held or 'locked' in place with a stone coping. A particular difficulty arises with this detail if there is damage to slates set below the coping, as the coping will need to be removed to allow for repair of the roof covering

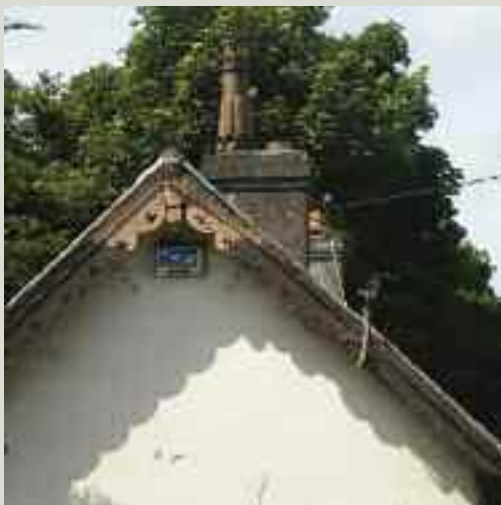
The poor condition of overhanging verges can lead to deterioration of the ends of the purlins as well as the loss of sections of decorative timber bargeboards

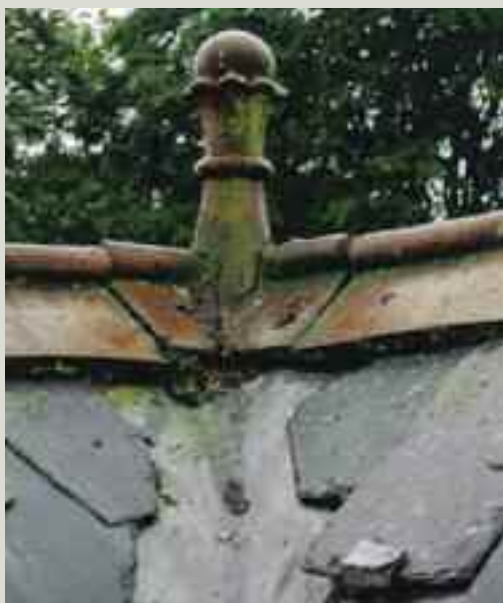
This terracotta ball finial was cracked; as part of a roof repair project it was removed, carefully cleaned and repaired before re-installment

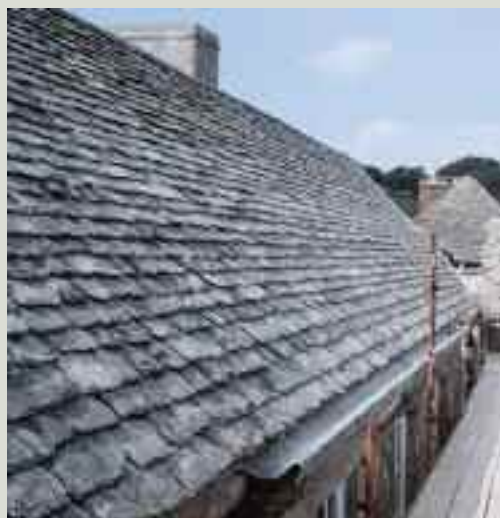
A new flush eaves gutter formed in lead along the top of the wall

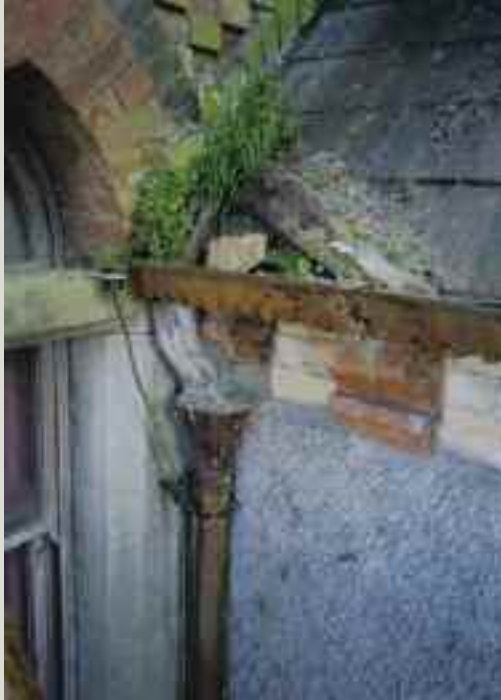
Cracked or broken rainwater goods can be replaced on a like-for-like basis with half round, box or ogee cast-iron gutter profiles which are readily available. Where castings are more decorative, such as in this case, new gutters can be cast to replace the broken sections. Downpipes should be carefully examined, cleaned down and fully refurbished on a regular basis

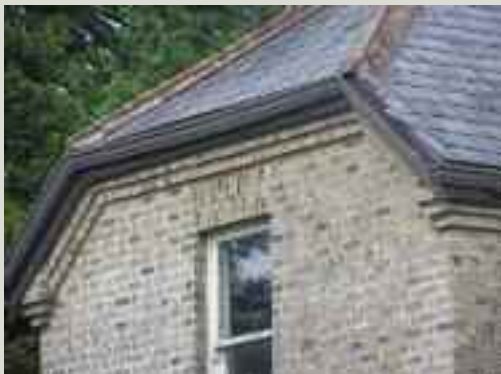
An unusual example of a decorative cast-iron gutter detail following the profile of a half-hipped roof

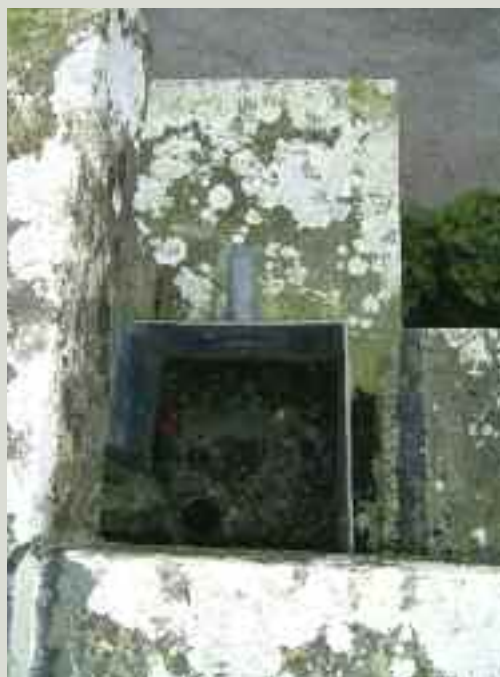
The installation of an early warning system in the form of an overflow pipe will alert the owner that the catchment pit is full and that a blockage in the gutter or hopper head needs to be cleared before excessive damage occurs

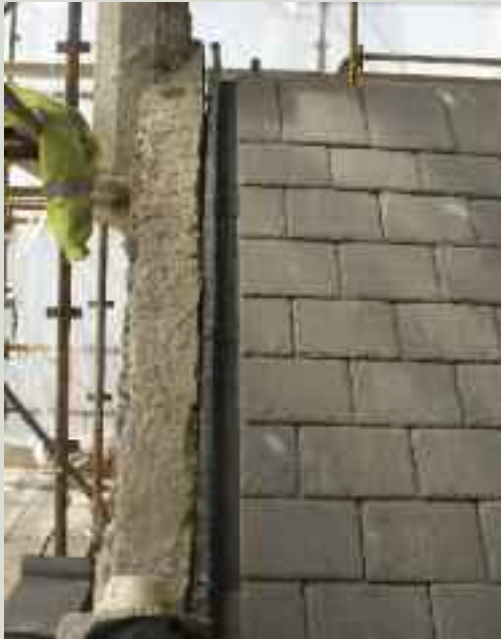
This so-called 'secret gutter' detail is not a traditional one. However, it may be recommended in instances where there is a history of water penetration below lead cover flashings at the junction with abutments, particularly on roofs of a low pitch (Note: in this image the gable capping stones have yet to be replaced)

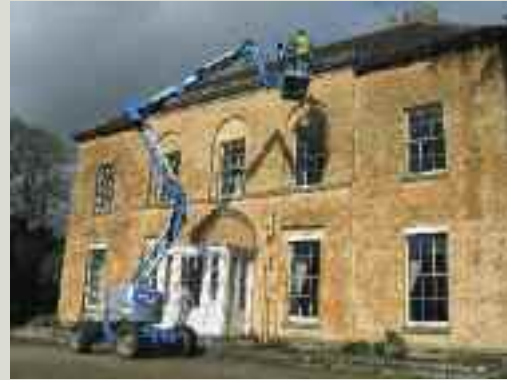
In some cases, the use of a cherry-picker may be an economical alternative to scaffolding for undertaking maintenance inspections and minor repair works to high roofs

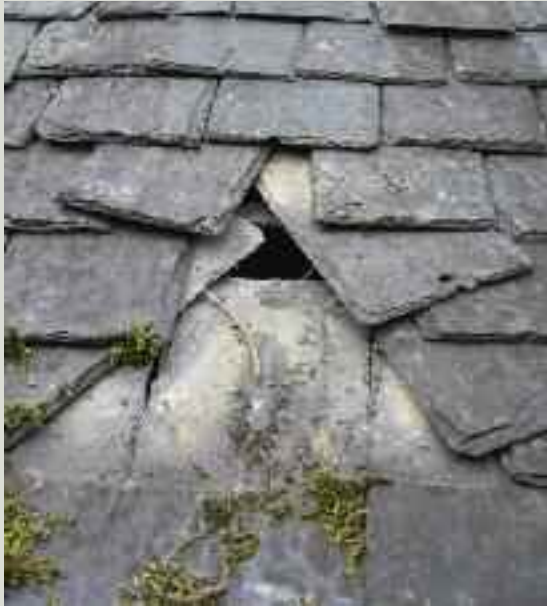
Earlier slate roofs using top-hung, single-nailed slates can easily be repaired by swinging individual slates aside allowing access to replace or re-peg the slates beneath

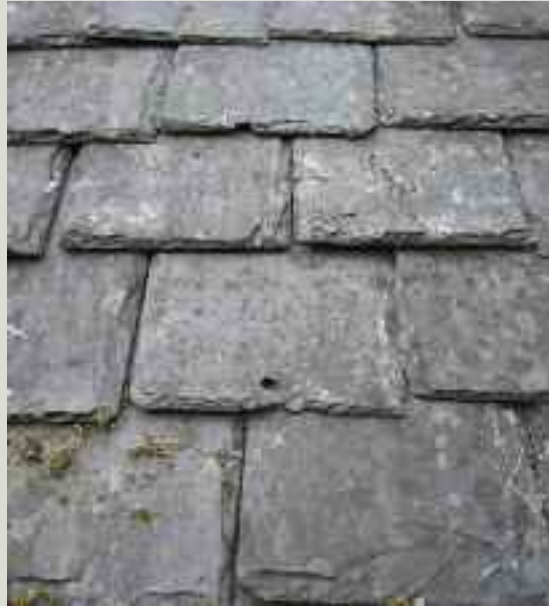
Slates are swung back into place after works

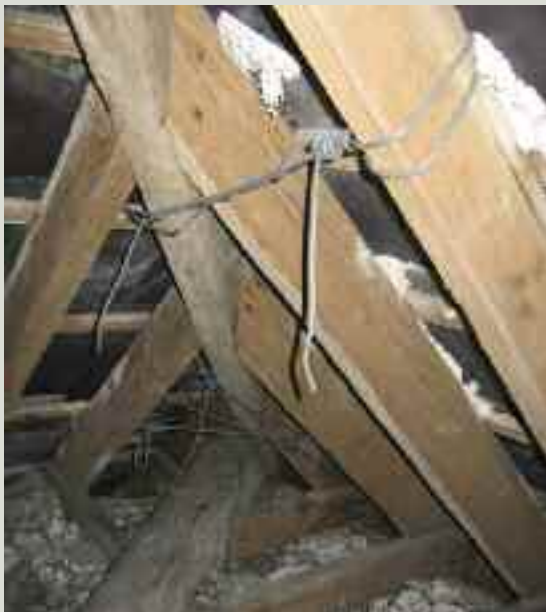
An alternative repair method is to tie the slates within the roof. This is useful where the slates are large or have square shoulders or, for some other reason, cannot be swung aside. A plastic-coated wire such as electrical lighting wire is threaded through the gap from inside the roof and attached to the slate outside. The slate is then carefully pulled back into position and the wire tied back to the timber roof structure

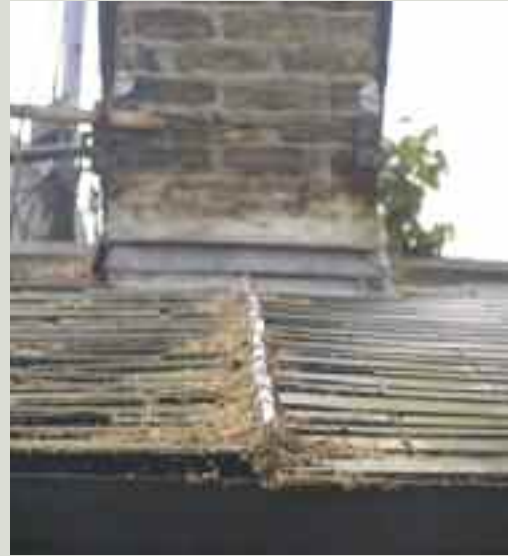
A lead divider batten roll can be used to disguise a difference in level caused by the use of deeper battens. The use of larger battens when re-roofing or the use of counter-battening with roof membranes can mean an increase in the roof plane height. This causes a difference in height between roofs in a terrace of buildings and a lead soaker may be used to accommodate the difference in levels

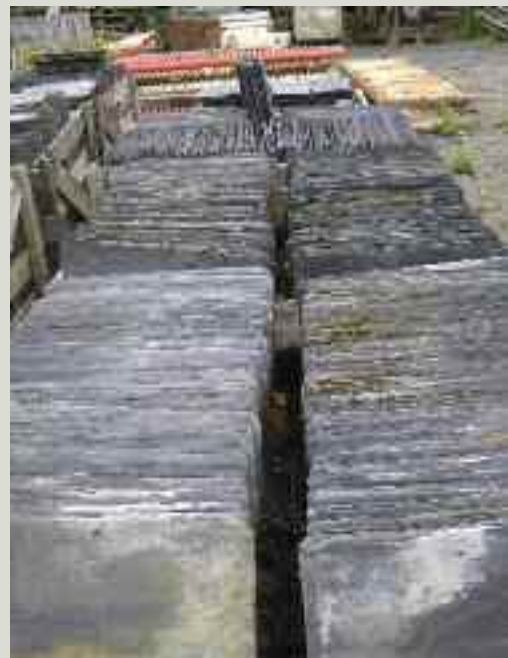
Slates properly stripped and sorted

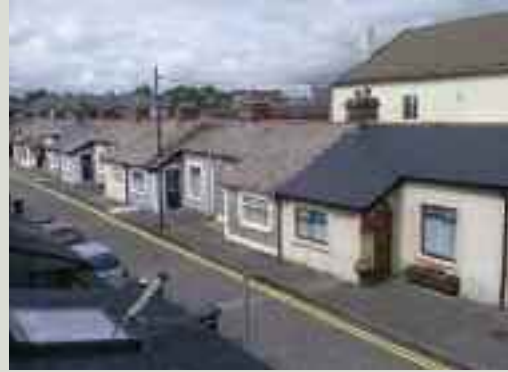
The mix of roofing materials on this terrace of houses visually fragments its appearance. The use of 'artificial slate', or fibre-cement tile is visible in the foreground, and also further down the street, striking discordant notes among the original slate-covered roofs

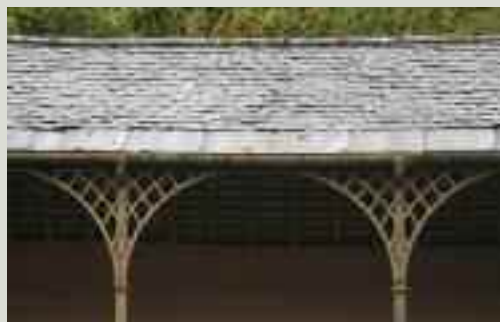
Large eaves slates helped to ensure that a good weatherproof detail was achieved where the accumulation of rainwater was greatest. It is a particular feature of historic slate roofs and should be retained when undertaking repair works

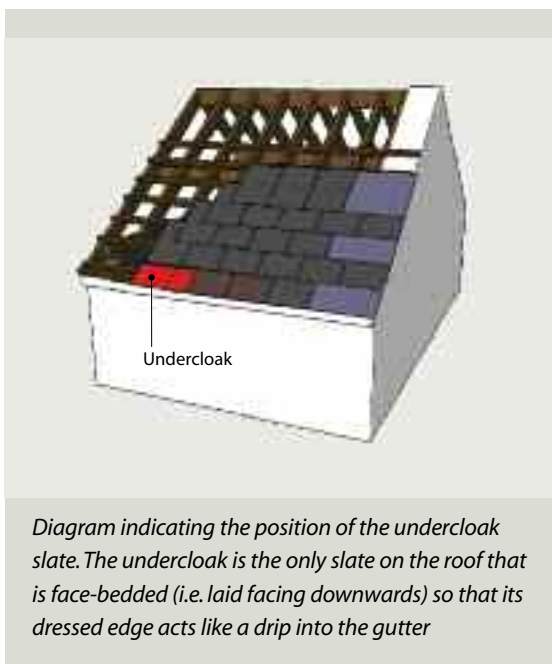
Diagram indicating the position of the undercloak slate. The undercloak is the only slate on the roof that is face-bedded (i.e. laid facing downwards) so that its dressed edge acts like a drip into the gutter

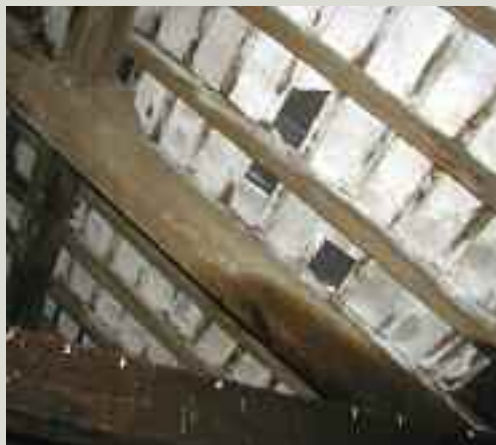
Substantially intact parging to the underside of slates is visible from within the attic space and provides a secondary line of defence against rain and wind entering the interior of the building

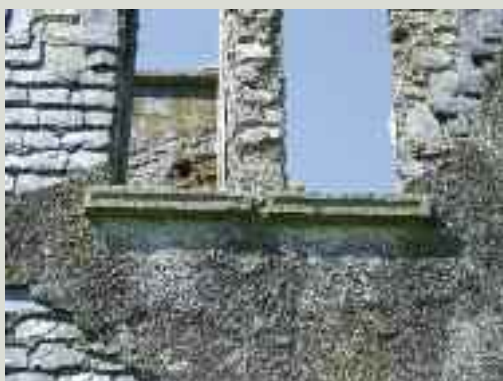
On this ruinous house in County Cork, the vertically hung slates, bedded in lime mortar, were later rendered over. Their existence only came to light as the external render decayed and fell off

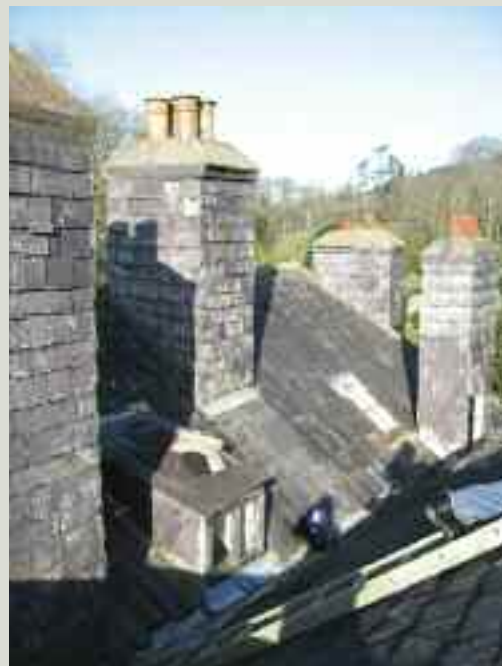
The change in colour of the slate on the chimneystack in the background indicates where a number of courses were removed and replaced. In areas of extreme weather exposure, vertically hung slating gives increased protection to the stacks

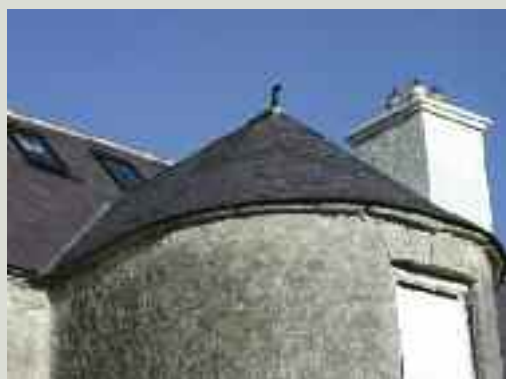
The repair of curved slate roofs is highly specialised work and requires a roofing contractor who has experience and skill in gauged work

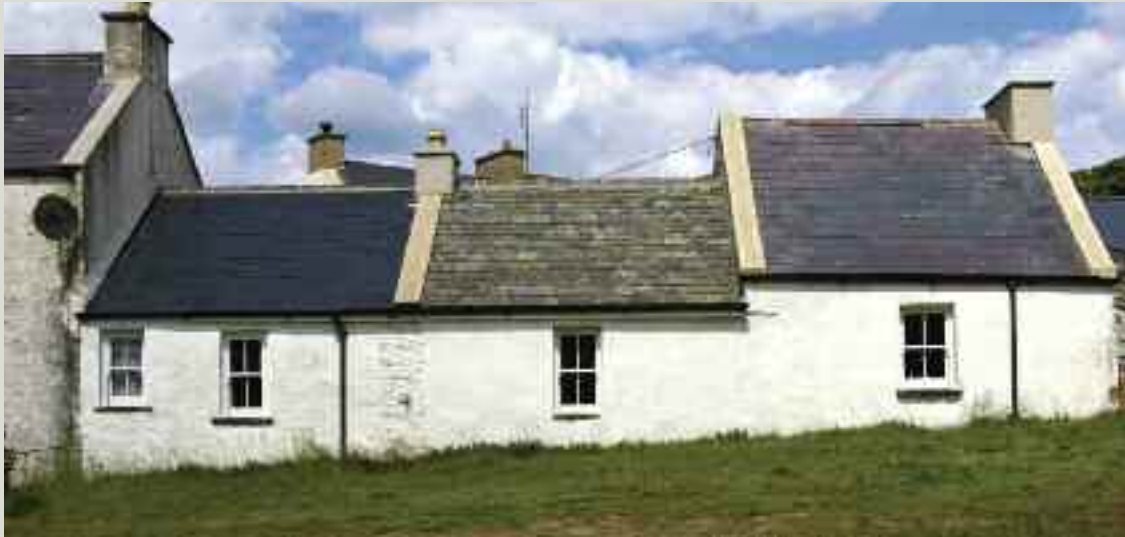
Most buildings using stone roofing slate are distinguishable by their simple gable-ended roofs. Hipped profiles, dormer windows, and valleys are difficult to achieve because of the large and somewhat unwieldy nature of the stone slate

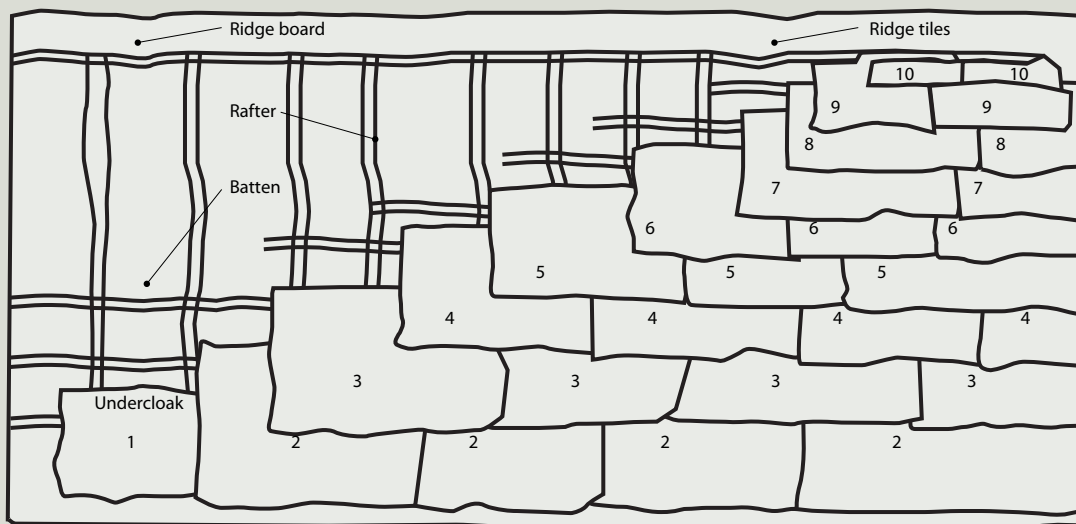
Graduated stone slates
Note: the distance between the battens decreases towards the top of the roof

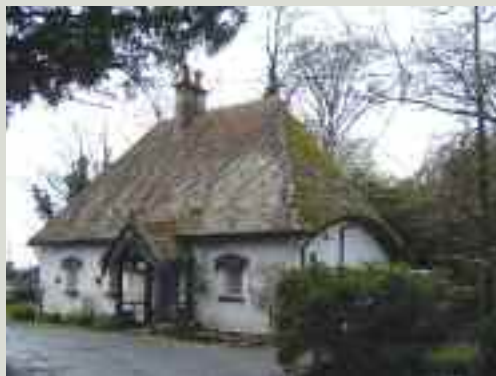
A gate lodge with a decorative clay-tiled roof, having striking curved elliptical eaves and a patterned use of plain and scalloped tiles. Overhanging branches and the proximity of large trees have tended to promote extensive moss growth on part of the roof

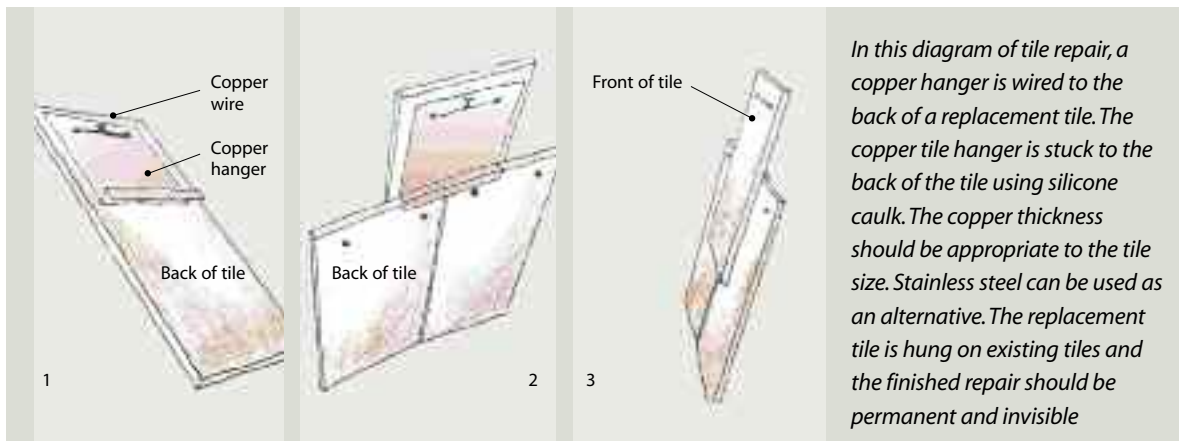
REPAIR OF TILED ROOFS

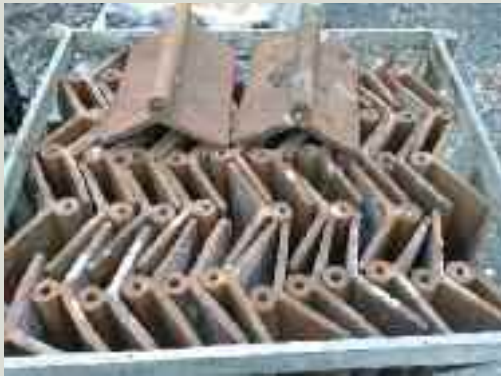
There is a wide range of clay ridge tiles available, including ornamentals, which enhance the character of a roof. These should be repaired or replicated as necessary, but not introduced unless there is evidence of their use on the building

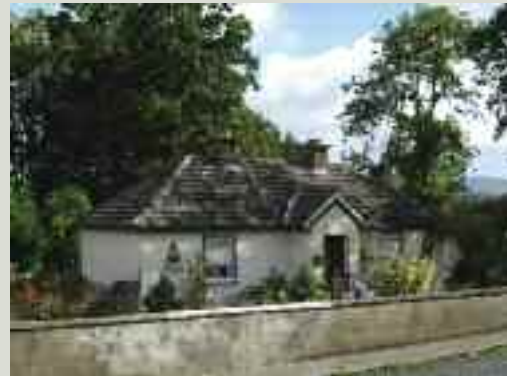
A Marley concrete roof tile on this modest 1940s cottage

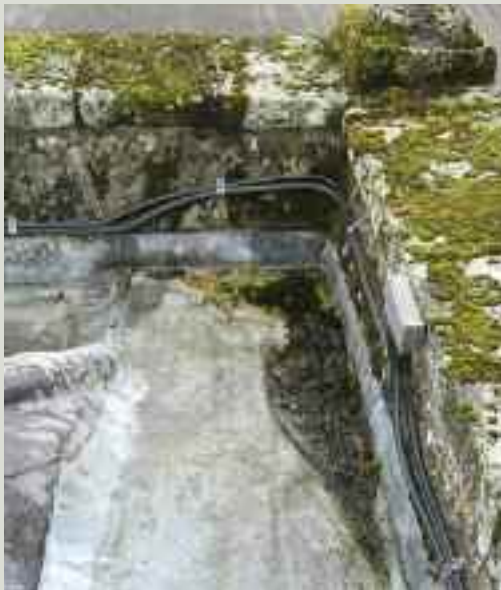
Ponding of water away from gutter outlets indicates a problem with the substrate timbers. In this case, a likely cause was poorly functioning flashings at the junction with the parapet wall

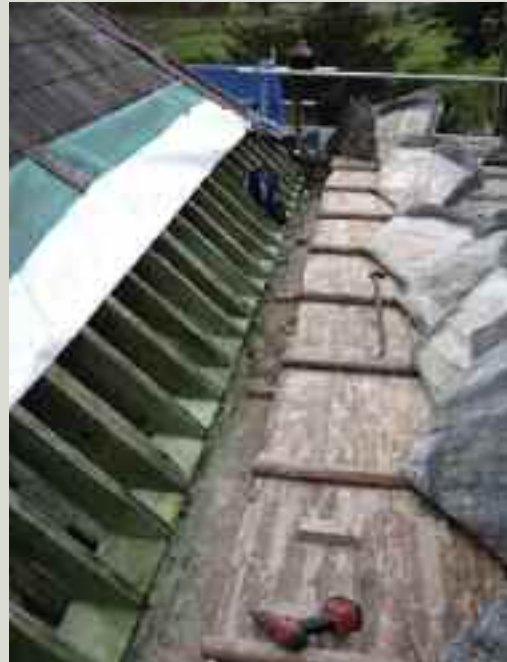
Slight lead corrosion can be seen on the exposed underside of the lifted lead sheeting on the right. The main problem here was a poorly detailed gutter. There was no need to change the regime of the flat roof, although good practice would include an underlay between the deal boards and the sheet lead

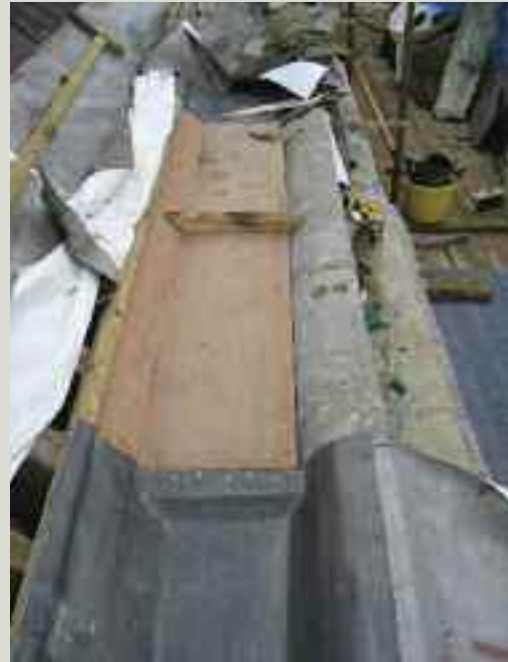
The design of this parapet gutter has been revised to achieve correct lead sheet lengths, falls and step heights in order to ensure that the newly-laid gutter will achieve a good lifespan. Note that the lead sheets have been fixed at the top end only (to allow for expansion and contraction), using copper nails in a staggered pattern

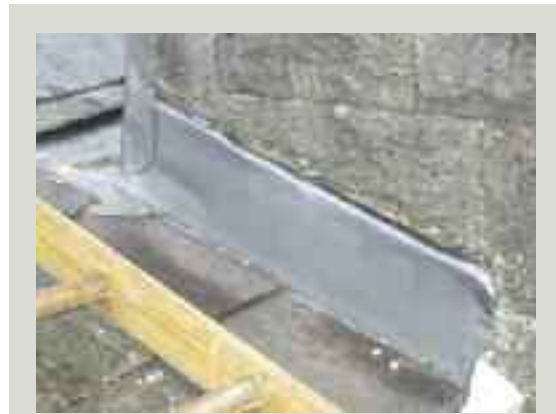
New lead flashing over lead soakers, turned into a mortar joint in the stonework at the base of a chimneystack and fixed using lead welts. The mortar joint is yet to be repointed

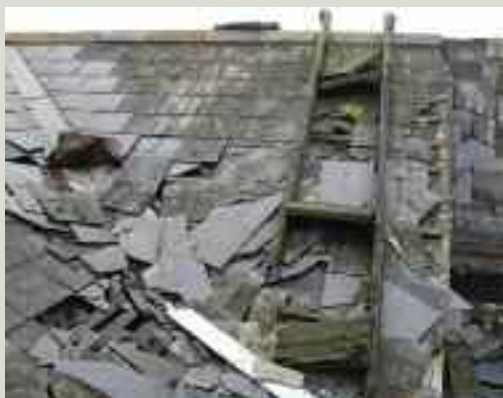
The theft of lead and copper from a historic roof can cause significant damage and leaves the interior of the building vulnerable to further damage from flooding

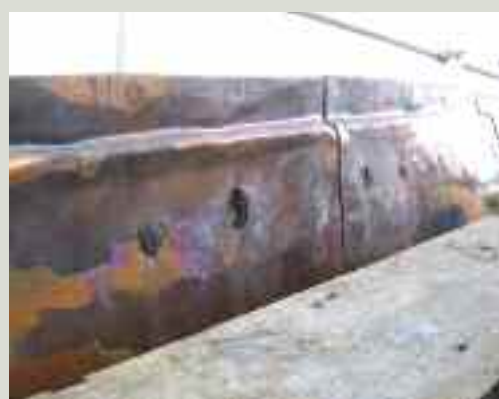
This copper parapet gutter lining has been lifted for inspection following water penetration problems. The bright salmon-coloured areas indicate that corrosion is occurring. Holes in the copper had been previously filled with a bitumen product in an earlier repair attempt which has exacerbated the problem, as bitumen corrodes copper

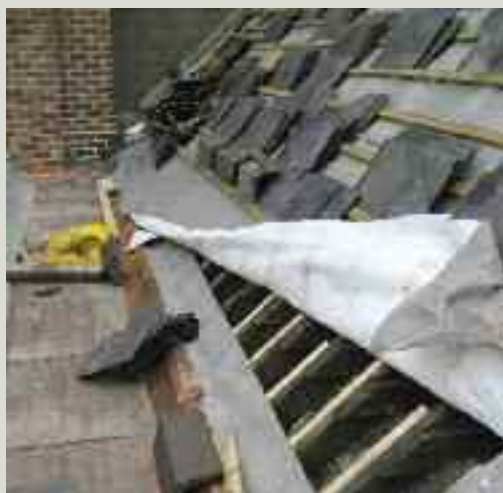
Re-lining a valley gutter in copper. Splice repairs were required to the ends of rafters where the previous valley had leaked over a significant length of time, causing decay of the timber structural elements below

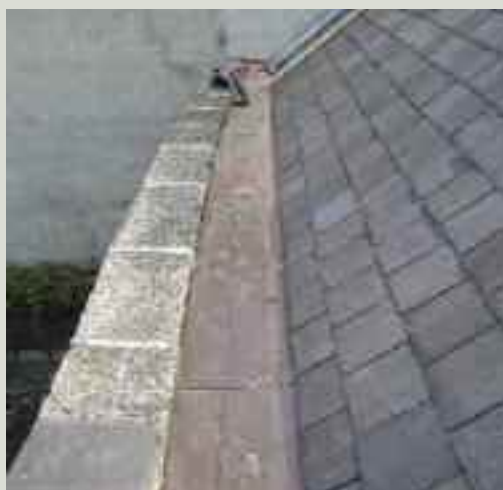
Parapet gutter re-lined in copper. The very shallow falls to this gutter precluded the use of lead

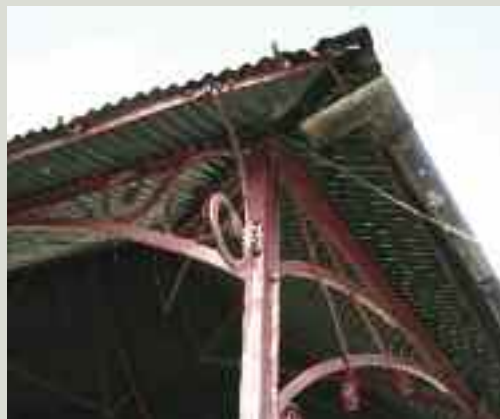
This corrugated iron is suffering from pitting, visible as small pinpricks of light where the metal has corroded through. There is also crevice corrosion occurring at the junction of the sheet with the hip roll. In addition, work is urgently needed to repair the rainwater goods

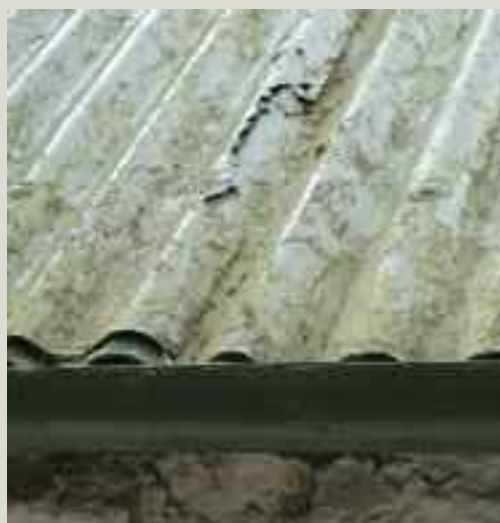
Crevice corrosion is frequently a problem with corrugated iron, particularly at the laps between corrugated sheets

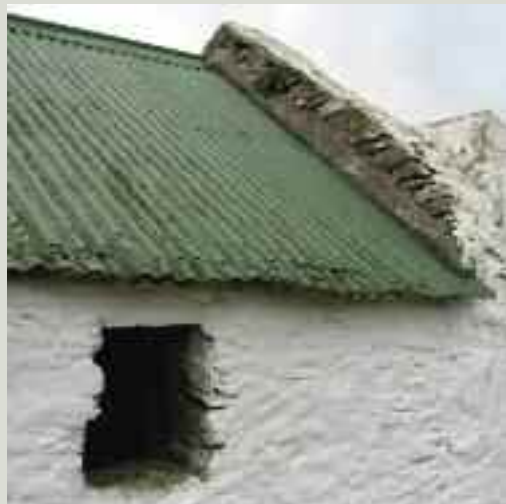
The eaves edge of corrugated-iron sheeting is particularly vulnerable to corrosion. Here, additional layers have been inserted under the eaves

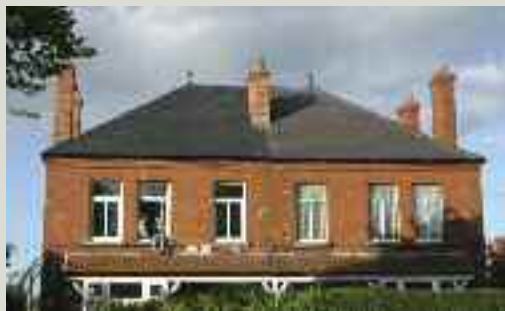
A recently replaced Welsh slate roof (to the left) adjoining a historic one (right), where the difference of character, colour and texture can easily be seen

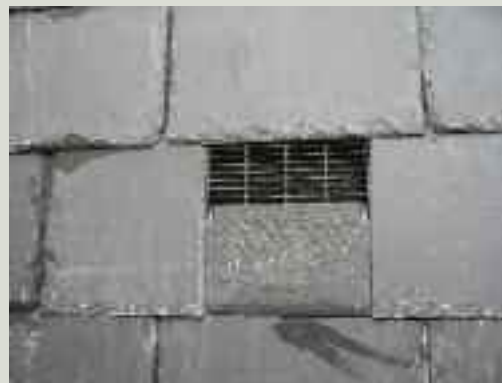
Example of an in-line slate vent. The vent will not protrude above the roof plane. However, such vents may be unacceptably conspicuous if used on the outward-facing slopes of a roof

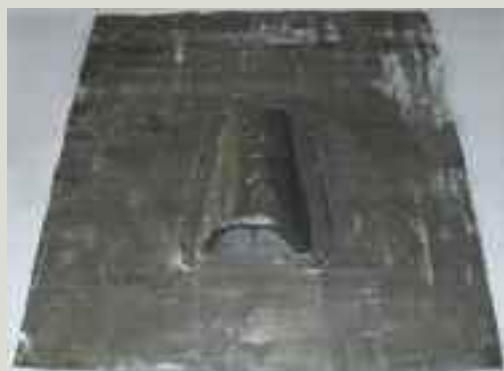
An especially formed lead vent with fly mesh, for use on a church roof. As they are quite distinctive and visible, the use of these vents on a roof where none existed previously should be discussed with the architectural conservation officer in the local authority

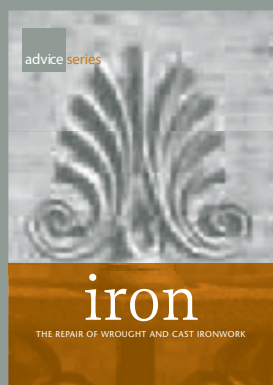
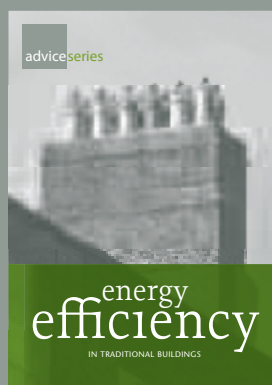
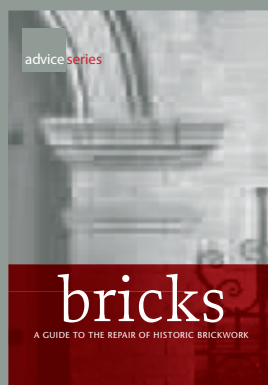
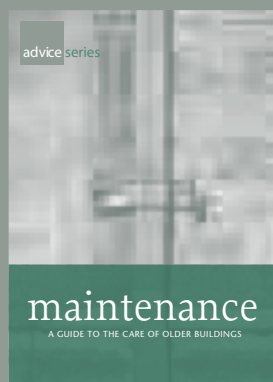
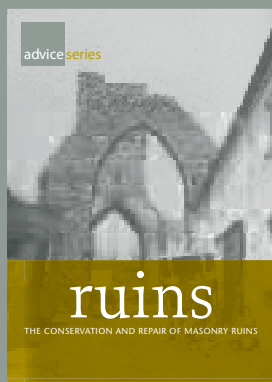
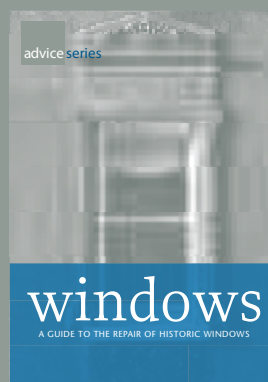
This guide will advise you in caring for your historic roof, helping you to:
