**PETRIFYING SPRING SURVEY AND ASSESSMENT
DODDER VALLEY PARK, SOUTH DUBLIN**

October 2020

**Report produced by Denyer Ecology for:
South Dublin County Council**

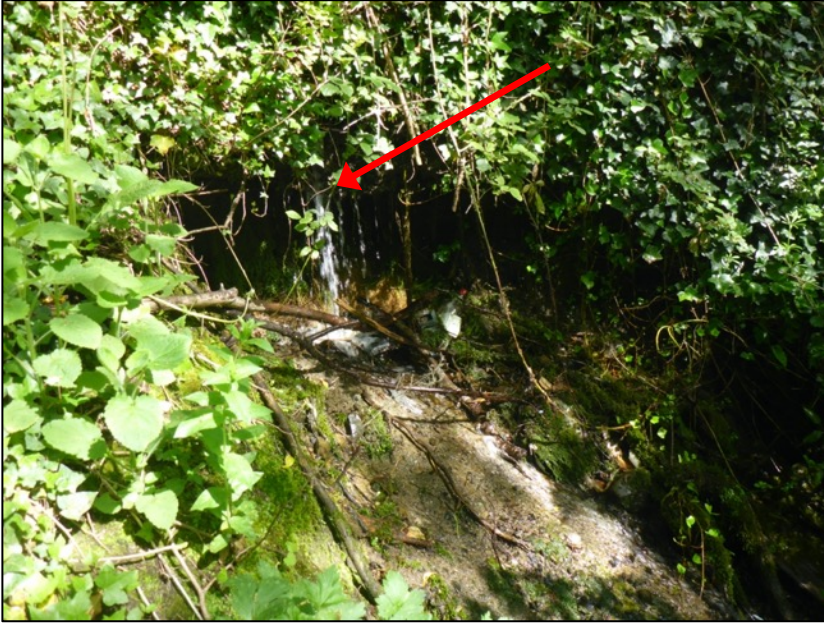
In addition, two streams/ discharges were recorded just outside of the northern boundary of the survey area (Figure 3.3). One of these (S1) discharges from a pipe in the river bank and flows downhill into the River Dodder. The second (S2) was recorded where it met the River Dodder (Photograph 3.1) and traced back as far as possible, but dense woody vegetation prevented the source being located. There were no signs of tufa or petrifying spring indicator species. SDCC advised that both of these discharges (S1 and S2) are stormwater outfall discharges (Figure 3.4).

Photograph 3.1. Stream/ discharge S1 arising from a pipe in the wooded riverbank (view to N)

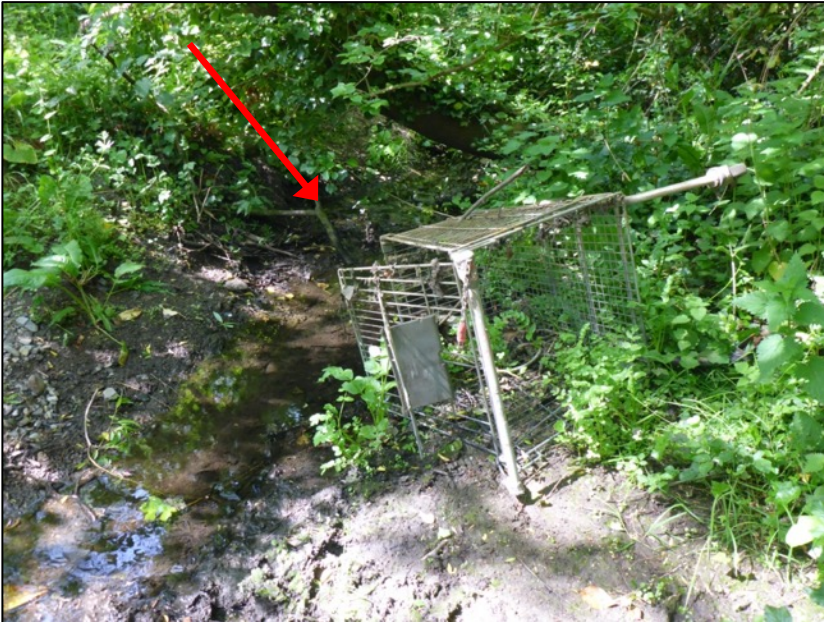
Photograph 3.2. Stream/ discharge S2 flowing into a channel of the River Dodder (view to NW)

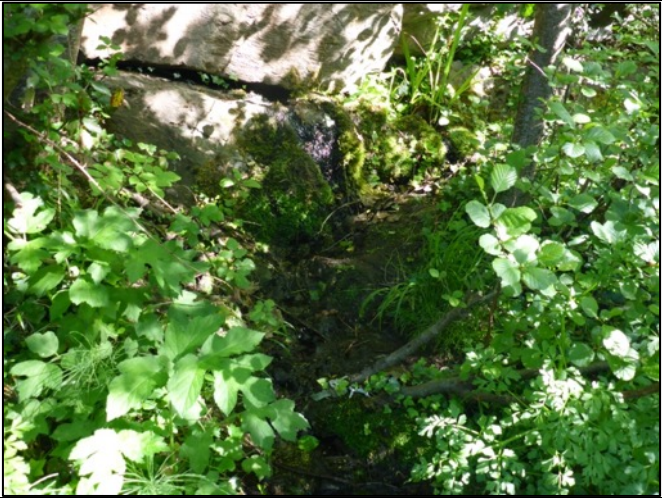
Spring number	Description	Detailed assessment?	Photo
Spring D01	Small spring arising in lower part of wooded riverbank. Steady flow of water despite recent dry weather. Two small channels which join and flow downstream into the river. Cascade tufa formation dominant with some paludal and stream crust tufa formation.	Yes. 3 positive indicator species + tufa formation = Annex I Petrifying spring

- Springs D01 and D02 failed the invasive species criteria as *Monbretia Crocosmia x crocosmiiflora* was present within the springs. There are only a few plants at present.

- Springs D01 and D02 failed the invasive species criteria as *Monbretia Crocosmia x crocosmiiflora* was present within the springs. There are only a few plants at present and these would be simple to remove. The springs would then pass the condition assessment.

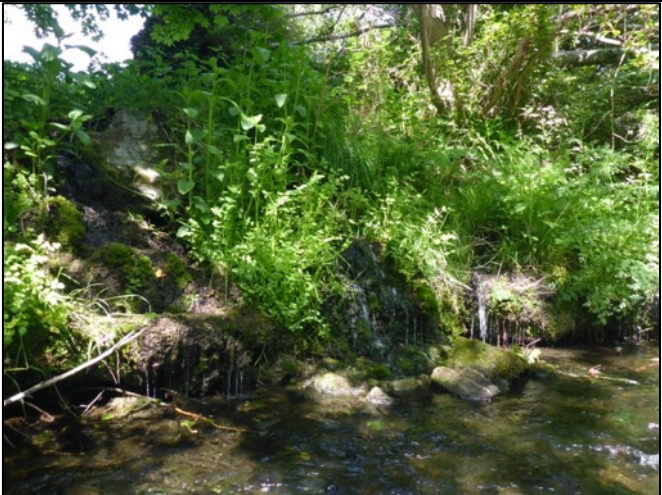
Spring D02	Main spring in area. Arises in upper part of wooded riverbank, two channels join and then flow down towards river in a single channel. At the riverbank it widens to flow over an area c5m wide with significant tufa formation. Strong flow despite recent dry weather. Cascade and paludal tufa formation in the upper part of the channel and large tufa cascades at the riverbank.	Yes. 4 positive indicator species + tufa formation = Annex I Petrifying spring

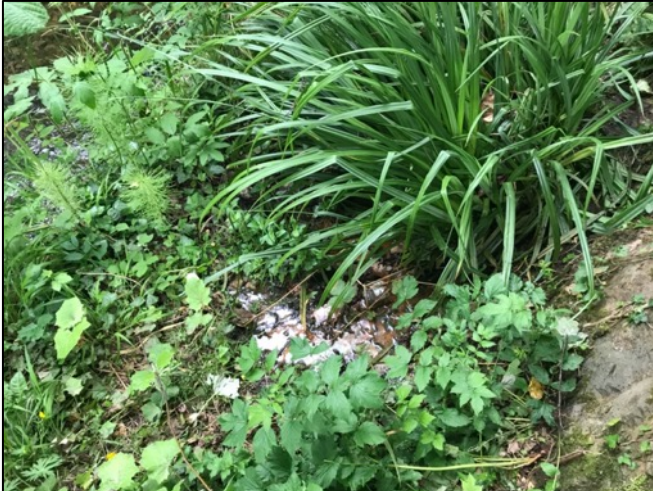
Spring number	Description	Detailed assessment?	Photo
Spring D03	Small iron seepage/ spring below rocks on lower riverbank near to spring D04. Tufa formation on bank under vegetation.	Assessed as part of the D03-D04-D08 seepage area.

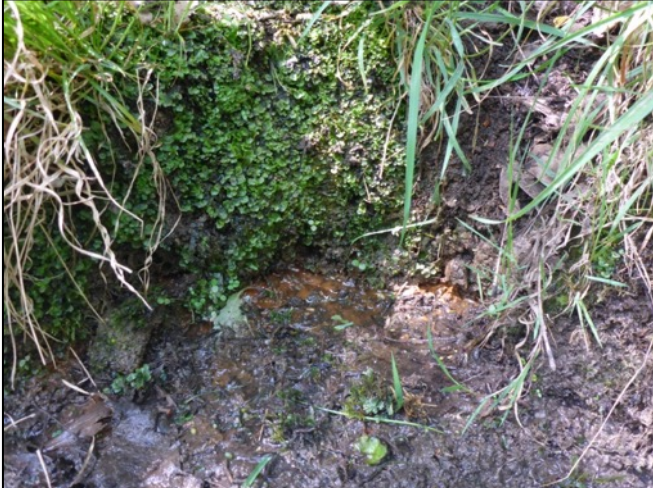
Spring D04	Small spring arising from a group of rocks in lower riverbank. Flows into small 'beach' area which is reasonably heavily used. The tufa formation is limited to the spring source which is near vertical on the rocks. Spring and vegetation less than 1m ² . However, some tufa formation present with typical spring species.	Yes. 3 positive indicator species + tufa formation = Annex I Petrifying spring

- Spring D04 fails on trampling as it discharges onto a small beach area which is heavily used by people and dogs. There was also litter present in the spring. The springhead is located on a vertical boulder face and is therefore protected from most damage. The spring seepage areas D03 and D08, which are associated with D04 were adjacent to a small woodland path and had some trampling damage, but this was much more localised.

- Spring D04 fails on trampling as it discharges onto a small beach area which is heavily used by people and dogs. There was also litter present in the spring. The springhead is located on a vertical boulder face and is therefore protected from most damage. Given the location of this small spring, it may not be possible to protect the seepage area from trampling. The spring

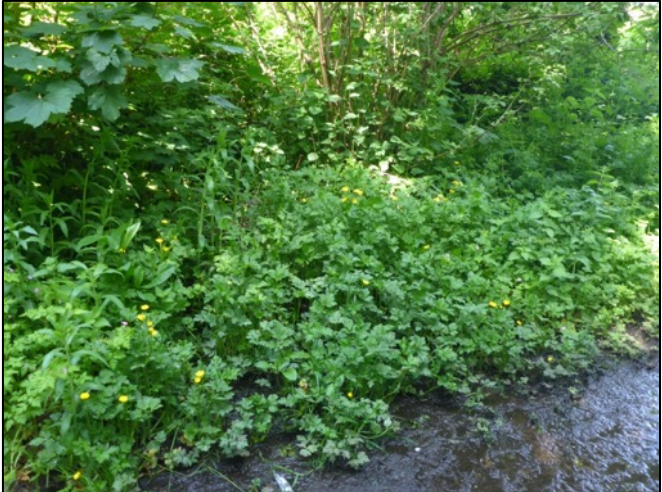
Spring number	Description	Detailed assessment?	Photo
Spring D05	Seepage area onto path above wooded riverbank. Seepage arises in small bank above path and flows through tall herb swamp vegetation and onto path below. No signs of seepage below the path down to riverbank.	No. No positive indicator species or tufa formation present.

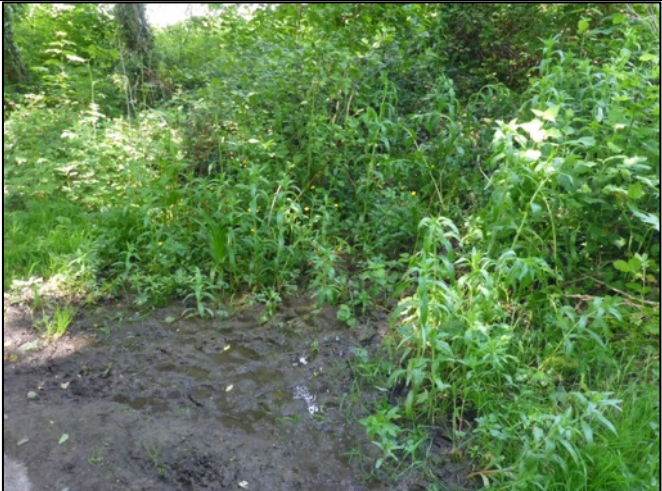
Spring D06	Seepage area onto path above wooded riverbank. Seepage arises in small bank above path and flows through tall herb swamp vegetation and onto path below. In contrast to spring D05, tufa formation is locally abundant in the form of oncoids/ ooids.	Yes. 0 positive indicator species but good tufa formation = potential Annex I Petrifying spring

- Spring D06 is not considered to be an example of the Annex I habitat ‘petrifying springs’. Tufa is frequent in the spring, but nutrient levels are high and the spring is dominated by tall-herb swamp vegetation and fails several of the condition assessment criteria. This spring originates in the bank above the river and may only recently have become wooded.

- Spring D06 is not considered to be an example of the Annex I habitat ‘petrifying springs’. Tufa is frequent in the spring but nutrient levels are high and the spring is dominated by tall-herb swamp vegetation and fails several of the condition assessment criteria. This spring originates in the bank above the river and may only recently have become wooded. This spring (and spring D05) have some trampling damage as they are adjacent to a surfaced path. The springs flow onto the path, creating a muddy area, but do not appear to continue the downslope of the path. It may be possible to create a channel under the path (or raise the path) to avoid damage to the spring and to facilitate flow down the hill. This would also make the path more accessible to path users. This should be discussed with a hydrogeologist to ensure a design which would not impact on the two springs.

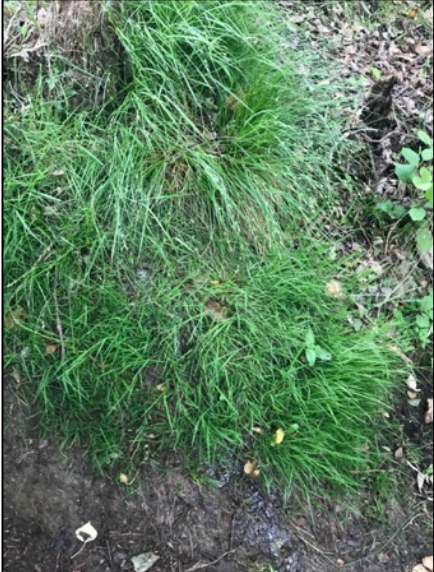
Spring number	Description	Detailed assessment?	Photo
Spring D07	Small seepage area on wooded bank. No obvious flow but ground damp. Vegetation dominated by <i>Carex remota</i> with <i>Agrostis stolonifera</i> . No tufa formation or petrifying spring indicator species present.	No. No positive indicator species or tufa formation present.

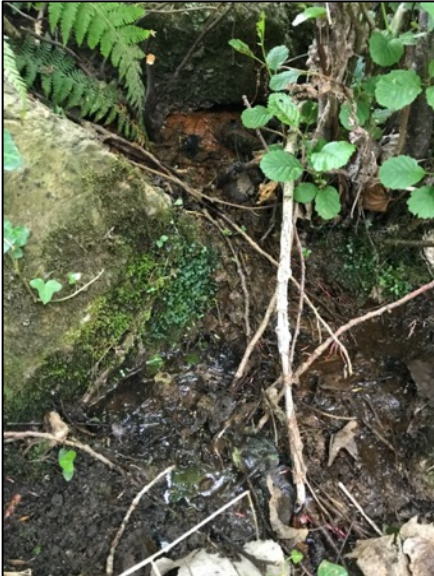
Spring D08	Small iron seepage/ spring on lower riverbank near to spring D03 and D04. Some sparse tufa formation on rocks.	Assessed as part of the D03-D04-D08 seepage area.

seepage areas D03 and D08, which are associated with D04 were adjacent to a small woodland path and had some trampling damage, but this was much more localised.

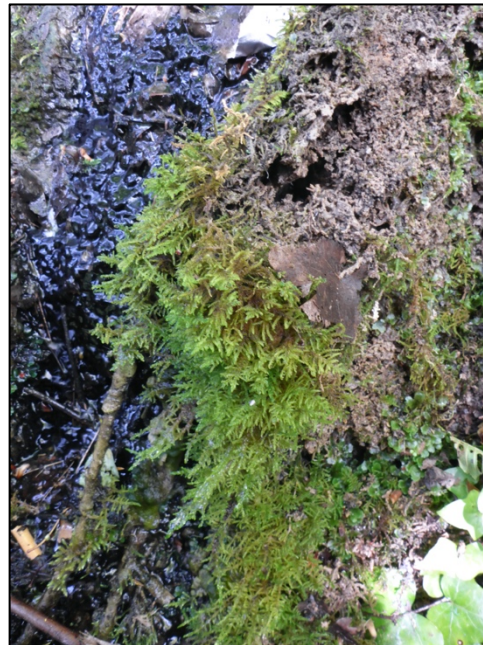
Photo 1.3. Cascade tufa with *Palustriella commutata* in relevé

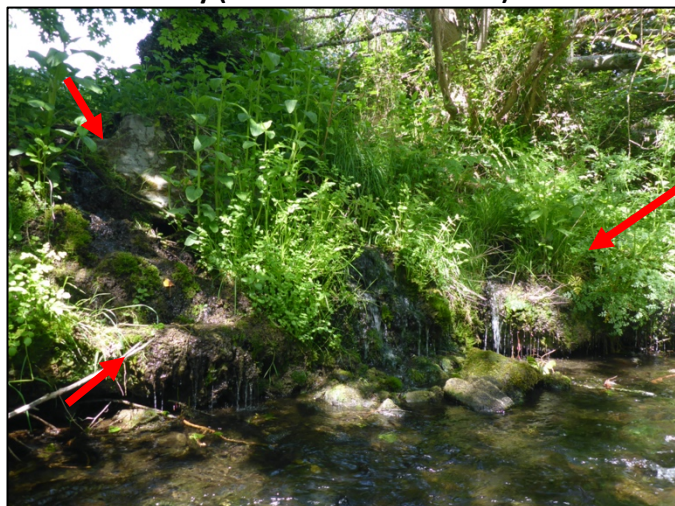
Photo 2.5. Extensive tufa formation at discharge point to Dodder Valley (arrows indicate extent)

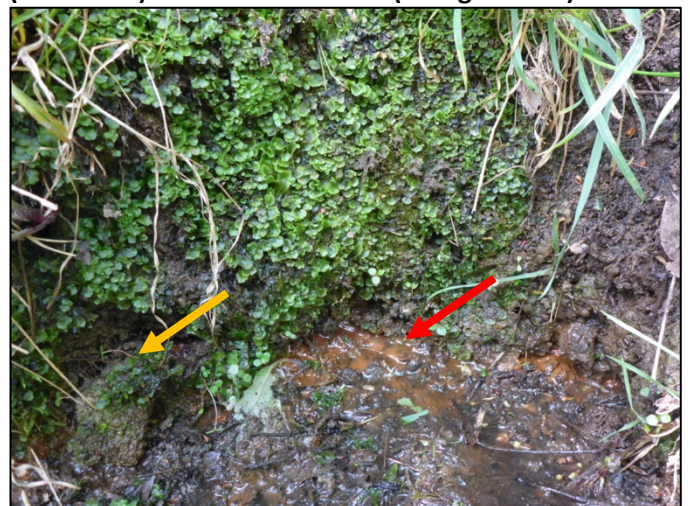
Photo 3.3. *Pellia endiviifolia* in relevé with iron staining (red arrow) and tufa formation (orange arrow)

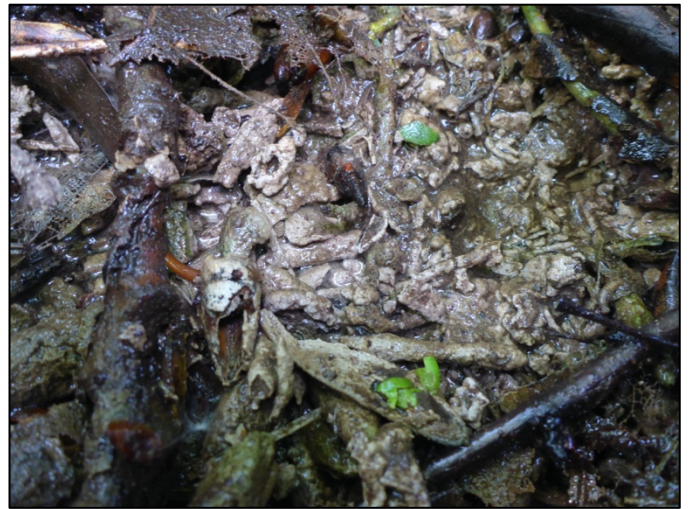
Photo 3.3. Oncoids/ ooids in relevé
