advice series

# energy efficiency

IN TRADITIONAL BUILDINGS

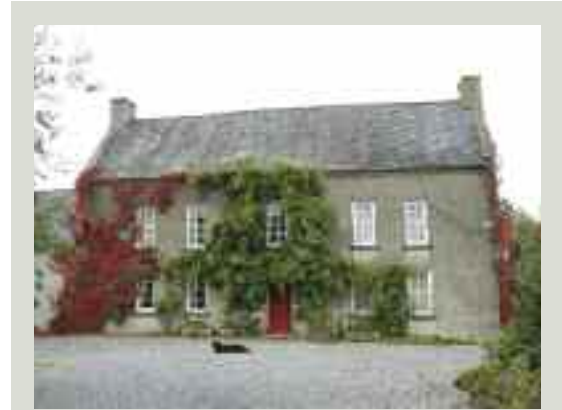
*A typical traditional farmhouse, built of stone and finished in lime render, with a slate roof and timber windows*

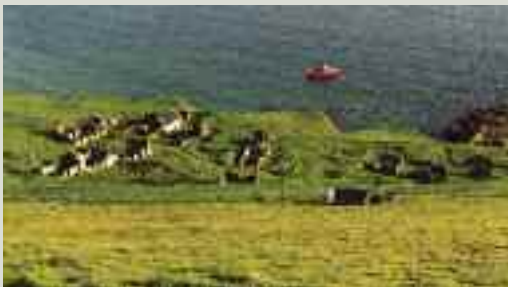
Houses on Great Blasket Island in lee of the hill with their gables turned towards the direction of the prevailing wind

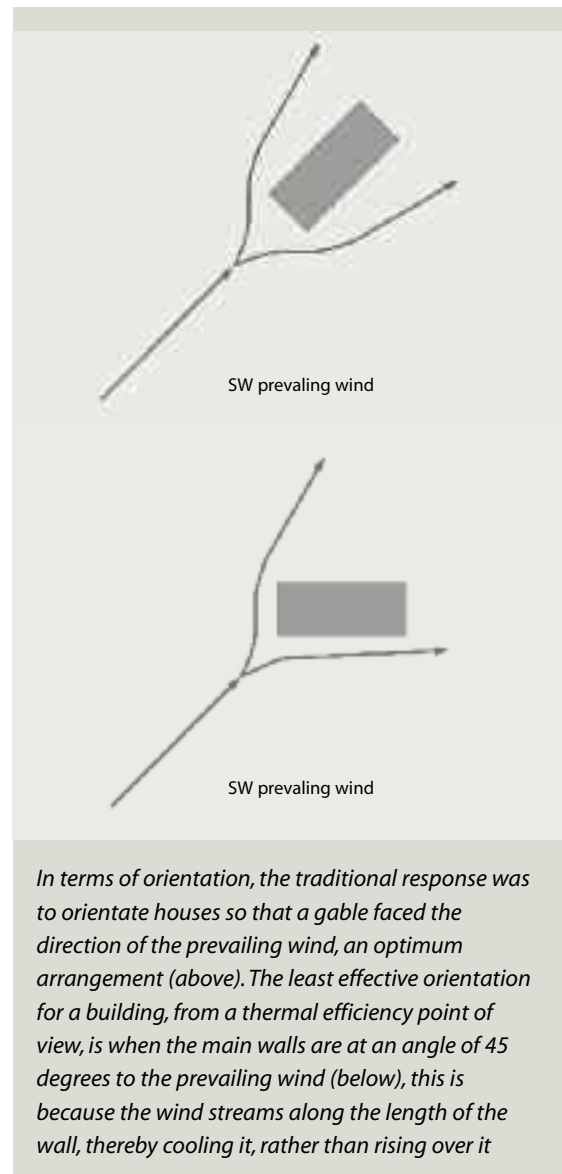
*In terms of orientation, the traditional response was to orientate houses so that a gable faced the direction of the prevailing wind, an optimum arrangement (above). The least effective orientation for a building, from a thermal efficiency point of view, is when the main walls are at an angle of 45 degrees to the prevailing wind (below), this is because the wind streams along the length of the wall, thereby cooling it, rather than rising over it*

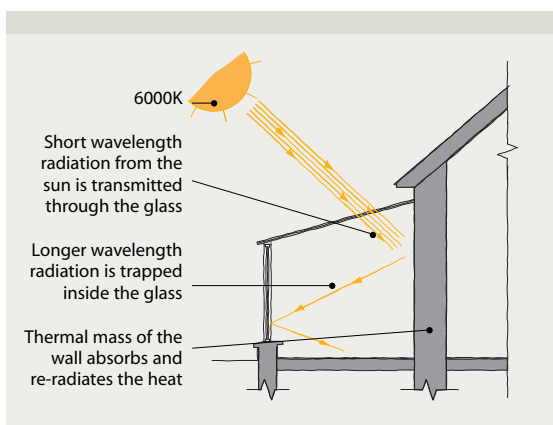
*Solar gain: the 'greenhouse' effect. Traditionally, conservatories and greenhouses were built to maximise the advantages of the heat from the sun; sunlight entering through the glass warmed the air inside allowing for the cultivation of exotic flowers and fruits. The conservatory also provided a room for entertaining which was a place of transition between the house and garden*

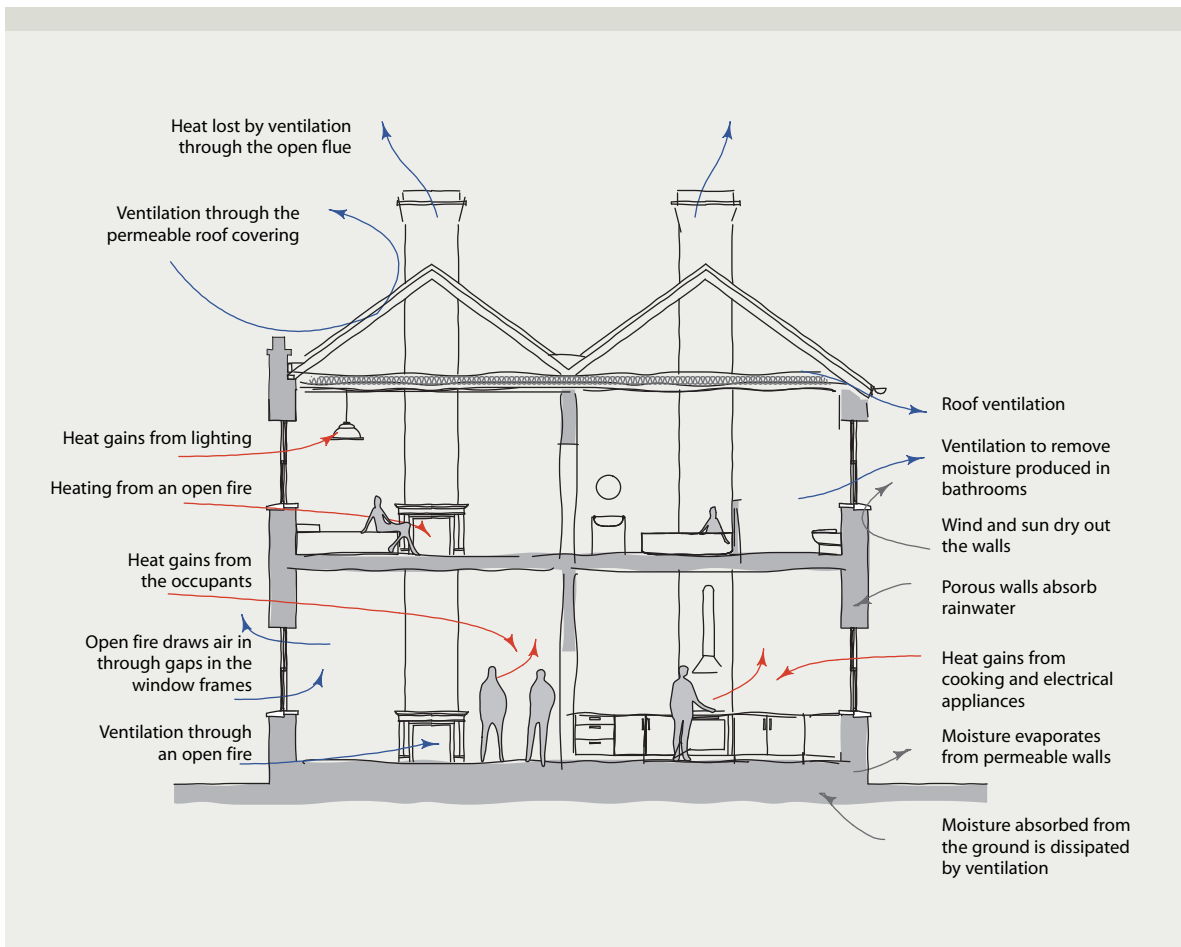
*A comparison of the ventilation and heating requirements for a traditional building (above) and a modern building (below)*

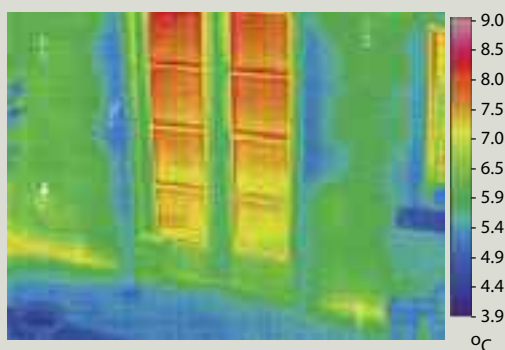
*A thermographic image of a double-glazed door at semi-basement level in a nineteenth-century terraced house; note how the yellow patches at the base of the wall, which are damper, indicate that these areas are emitting heat at a higher rate than the rest of the wall*

Thermal imaging can be used to identify potential problems with a building's fabric. When looking at traditional buildings, thermal imaging might be used to identify areas of dampness and to locate thinner depths of wall, cracking and voids. Expertise is required both in deciding how and when to take IR images and later in interpreting the information. For example, objects which have high or low emissivity such as metal do not give an accurate temperature reading. Weather conditions, orientation and the time of day when the image was taken all have the potential to affect the reading. The information gathered from thermal images can be properly assessed only in conjunction with data gathered as part of a comprehensive condition survey.

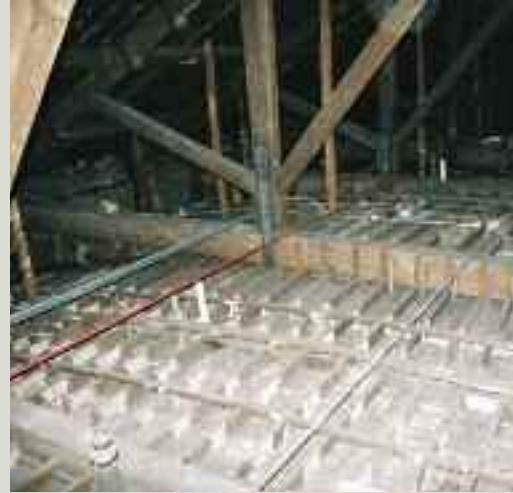
*A large roof space with no insulation above the ceiling; while the heat rising from the building interior may benefit the timber and other building materials in the roof space, a lot of energy is wasted in this way*

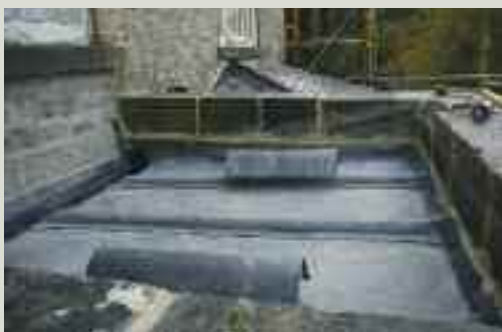
*A recently re-covered lead flat roof. These modern lead roof vents were introduced as, previously, poor ventilation had caused moisture to build up within the roof space leading to timber decay*

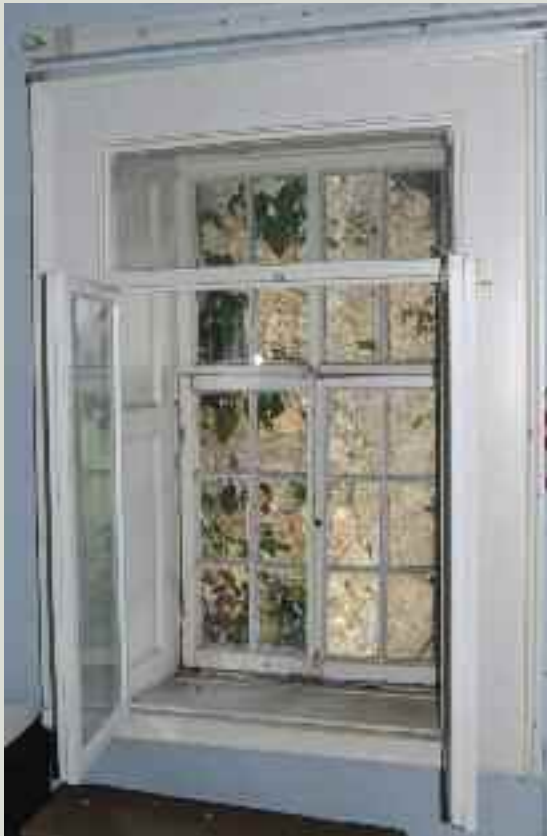
*An Edwardian window with 1950s secondary glazing. The secondary glazing is chunky and does not match the original window profile and blocks light from the room. The position of the frame within the opening prevents the shutters from being used*

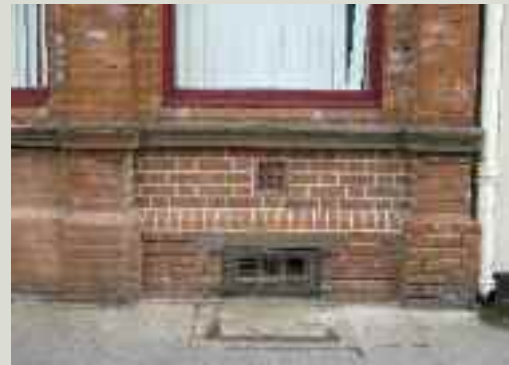
*A floor vent to ventilate the ground floor was built into the wall between the cellar and ground floor windows as part of the original design*

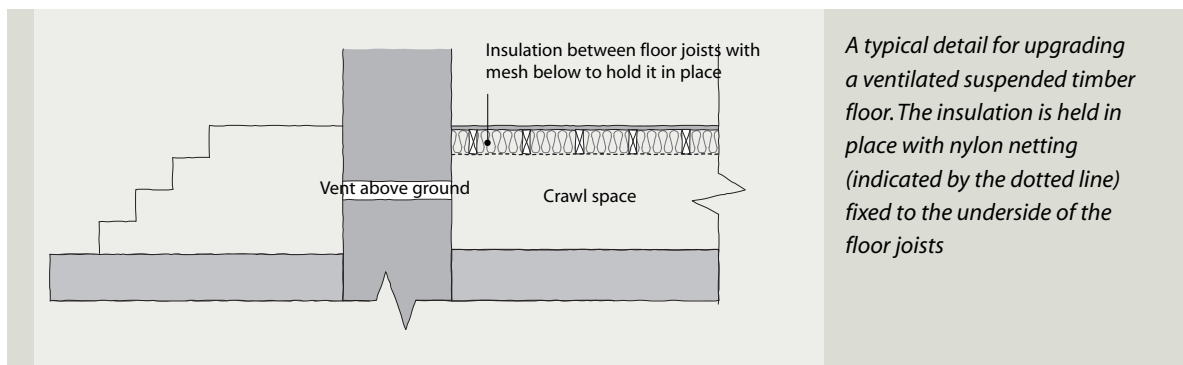
*A typical detail for upgrading a ventilated suspended timber floor. The insulation is held in place with nylon netting (indicated by the dotted line) fixed to the underside of the floor joists*

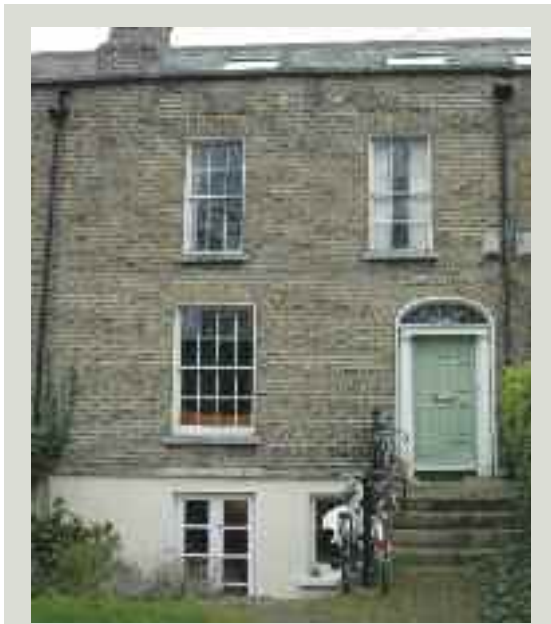
*The brick façade from 1821 was later repointed using a sand and cement mortar. While the removal of this pointing and its replacement with a vapour-permeable lime-based mortar would benefit the building, it is likely that the process of removal of the pointing would cause unacceptable damage to the brickwork*

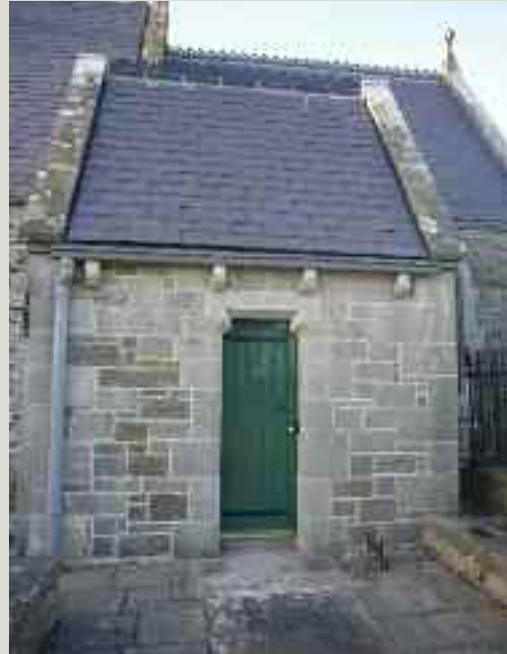
*A special detail was used to deal with the small additional height that resulted from adding insulation to the roof build-up; stone blocks were added under the reinstated cast-iron gutter*
